BROOKVALE RESIDENTIAL

GEOTECHNICAL ASSESSMENT REPORT

INITIA REF P-001006 REV A

FEBRUARY 2021

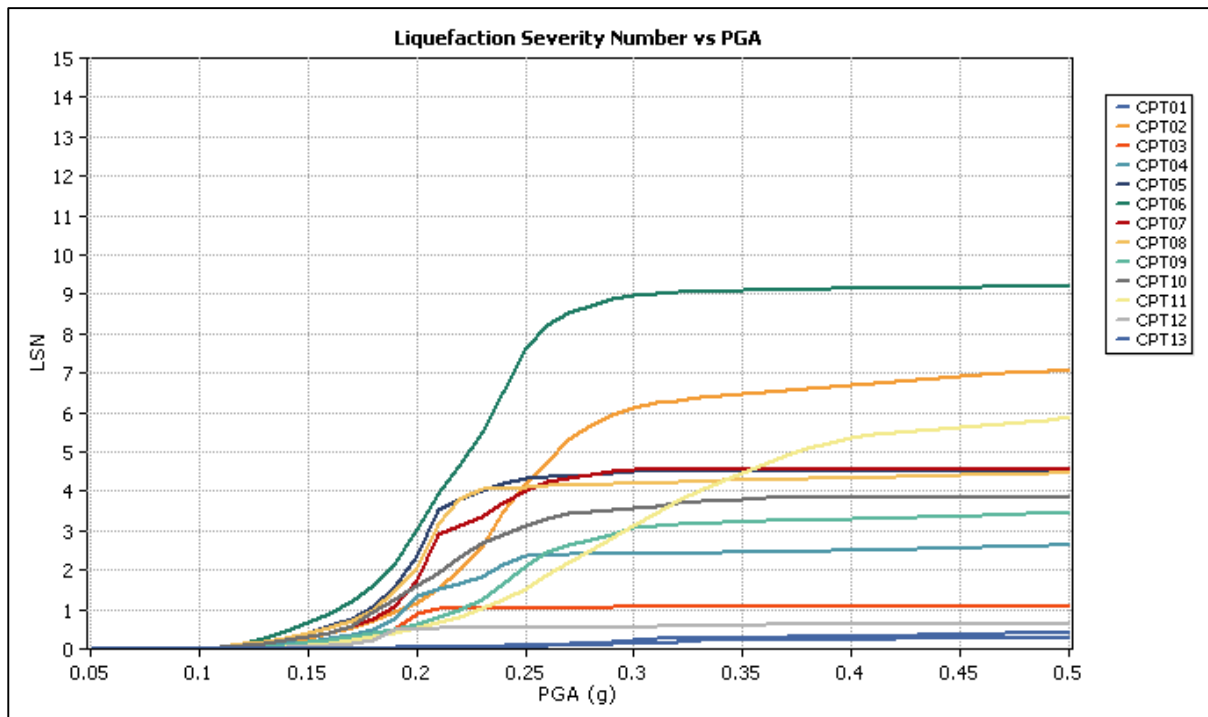
Figure 4-1: Sensitivity of LSN to PGA

Our analyses indicate that liquefaction triggers at about 0.2 g (above SLS levels of shaking), and full liquefaction over the depths investigated is likely to be triggered at about 0.25 g as shown on Figure 4-1 below. This equivalent to about a 1 in 250 year event.

LSN values range between 1 and 9 (on average 4) under ULS levels of shaking which suggests there will be little to no expression of liquefaction.

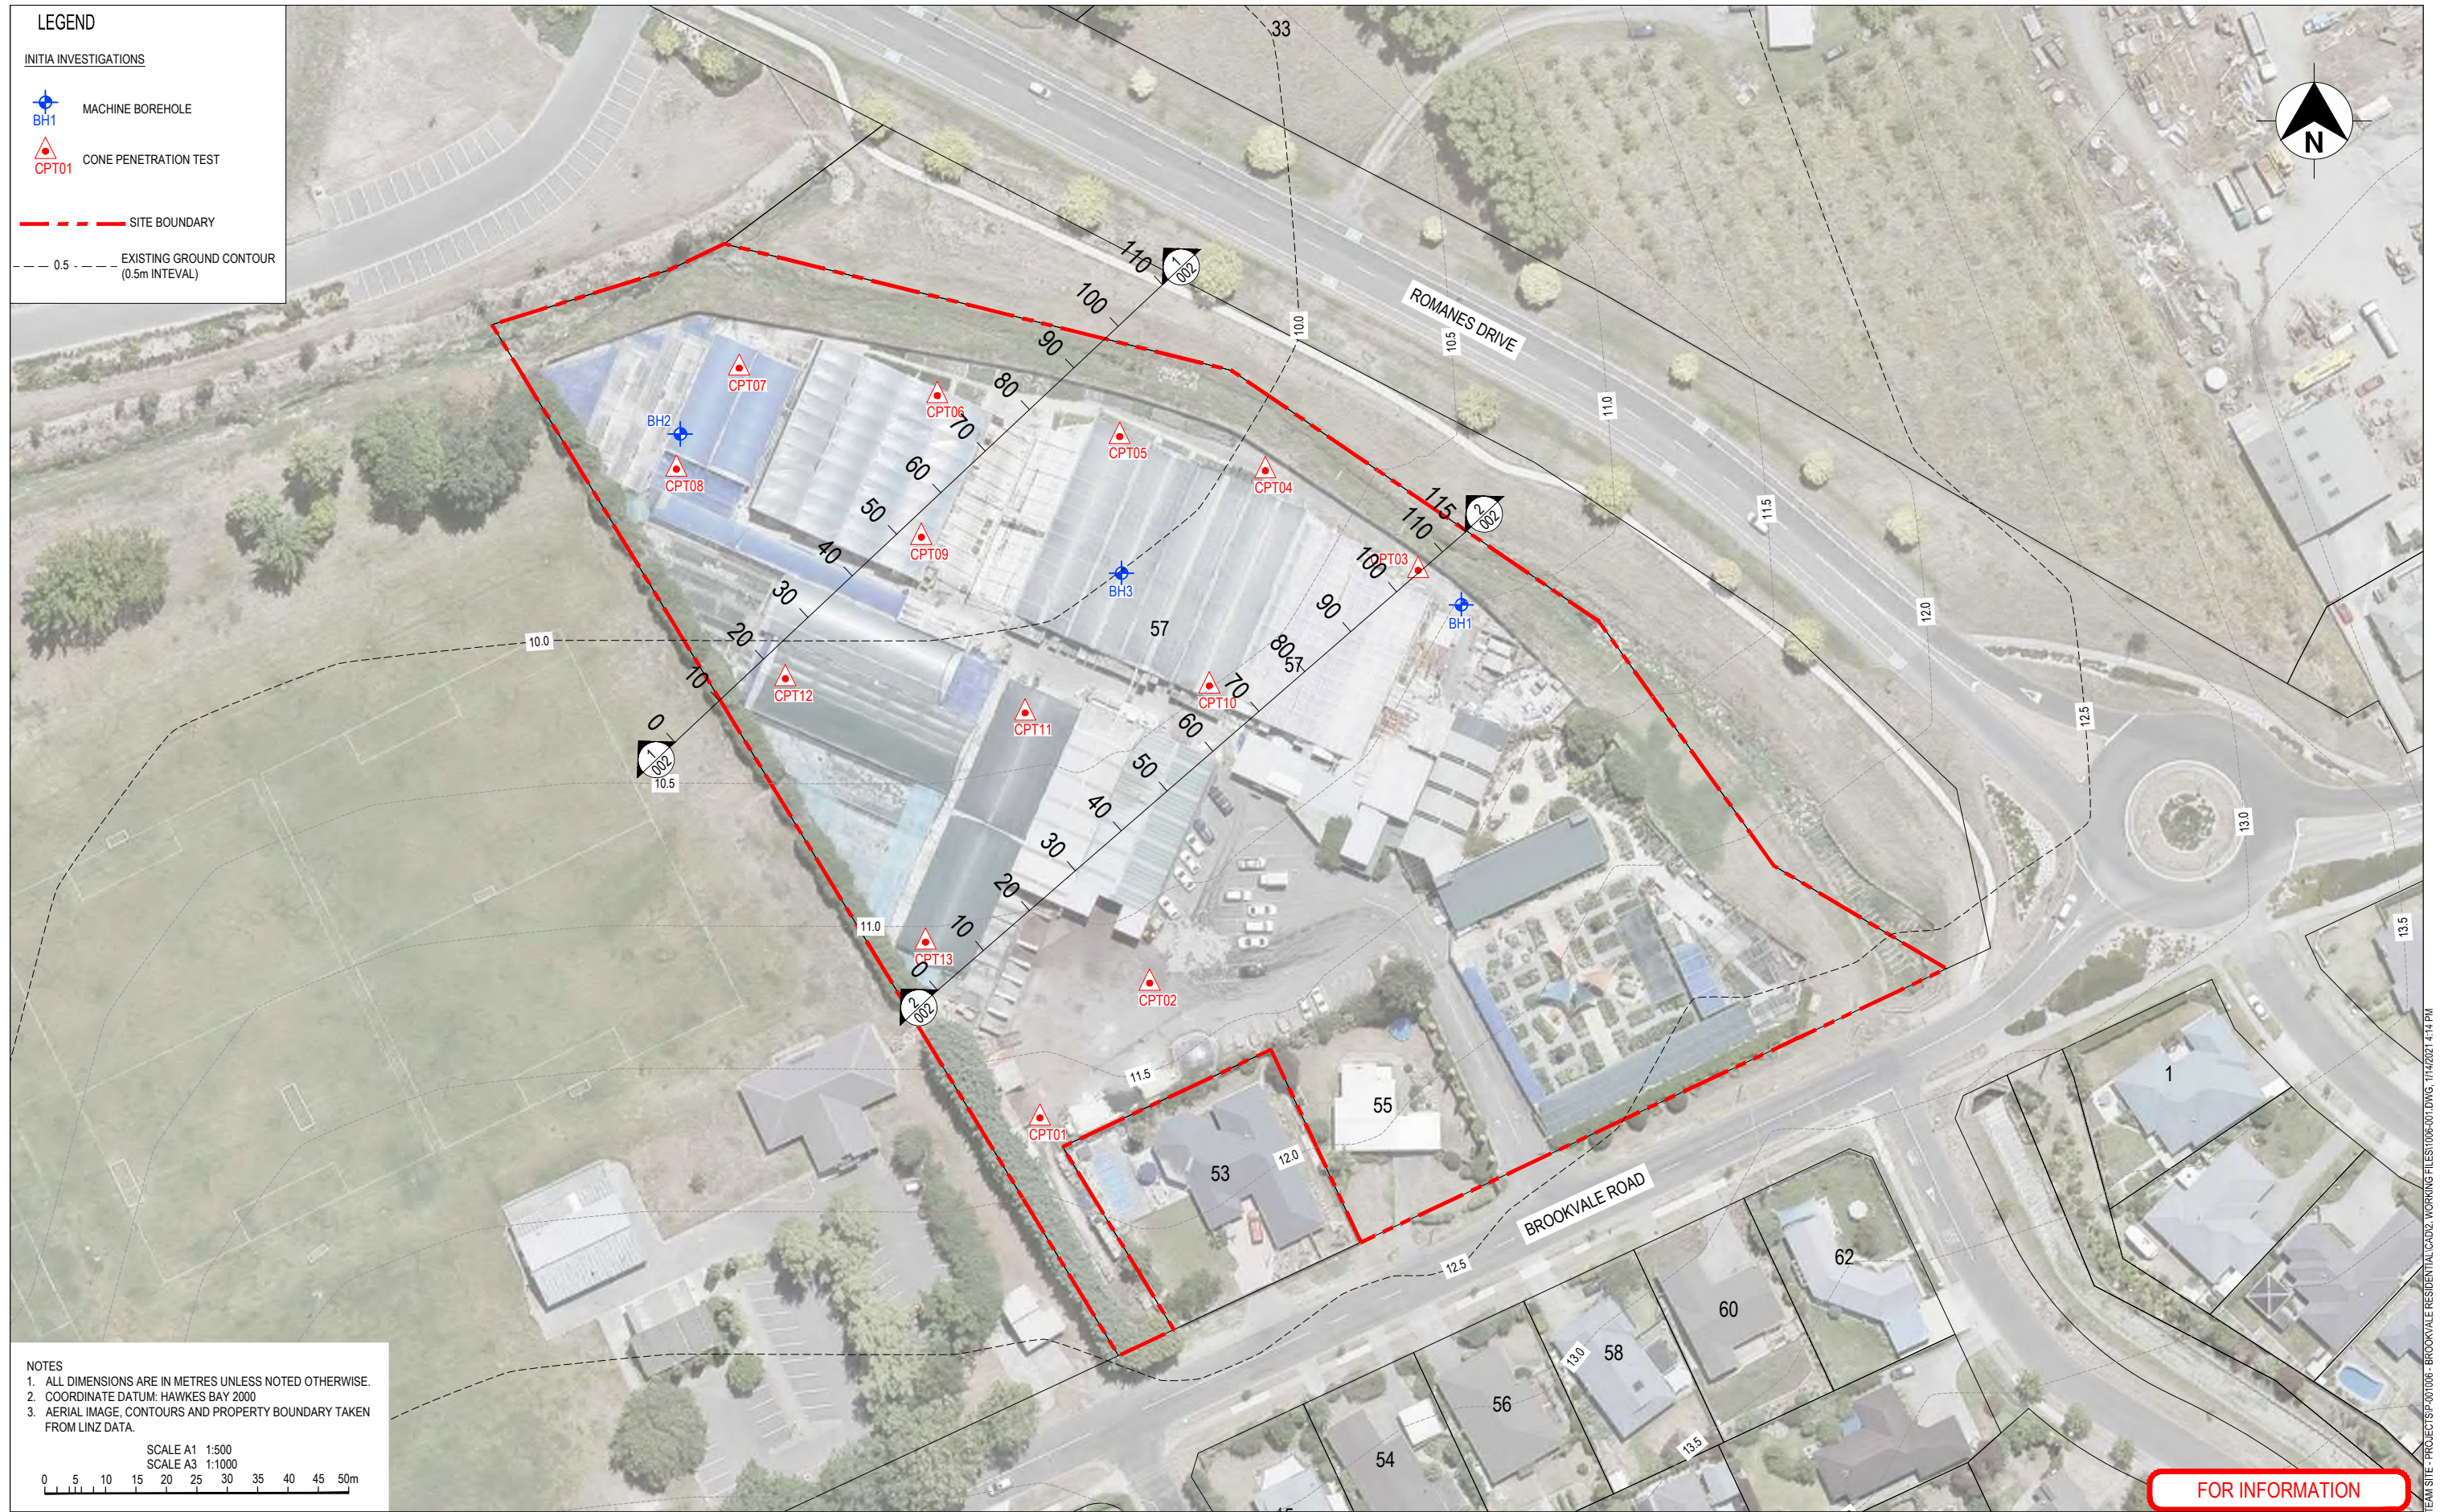
EXISTING GROUND CONTOUR (0.5m INTERVAL)

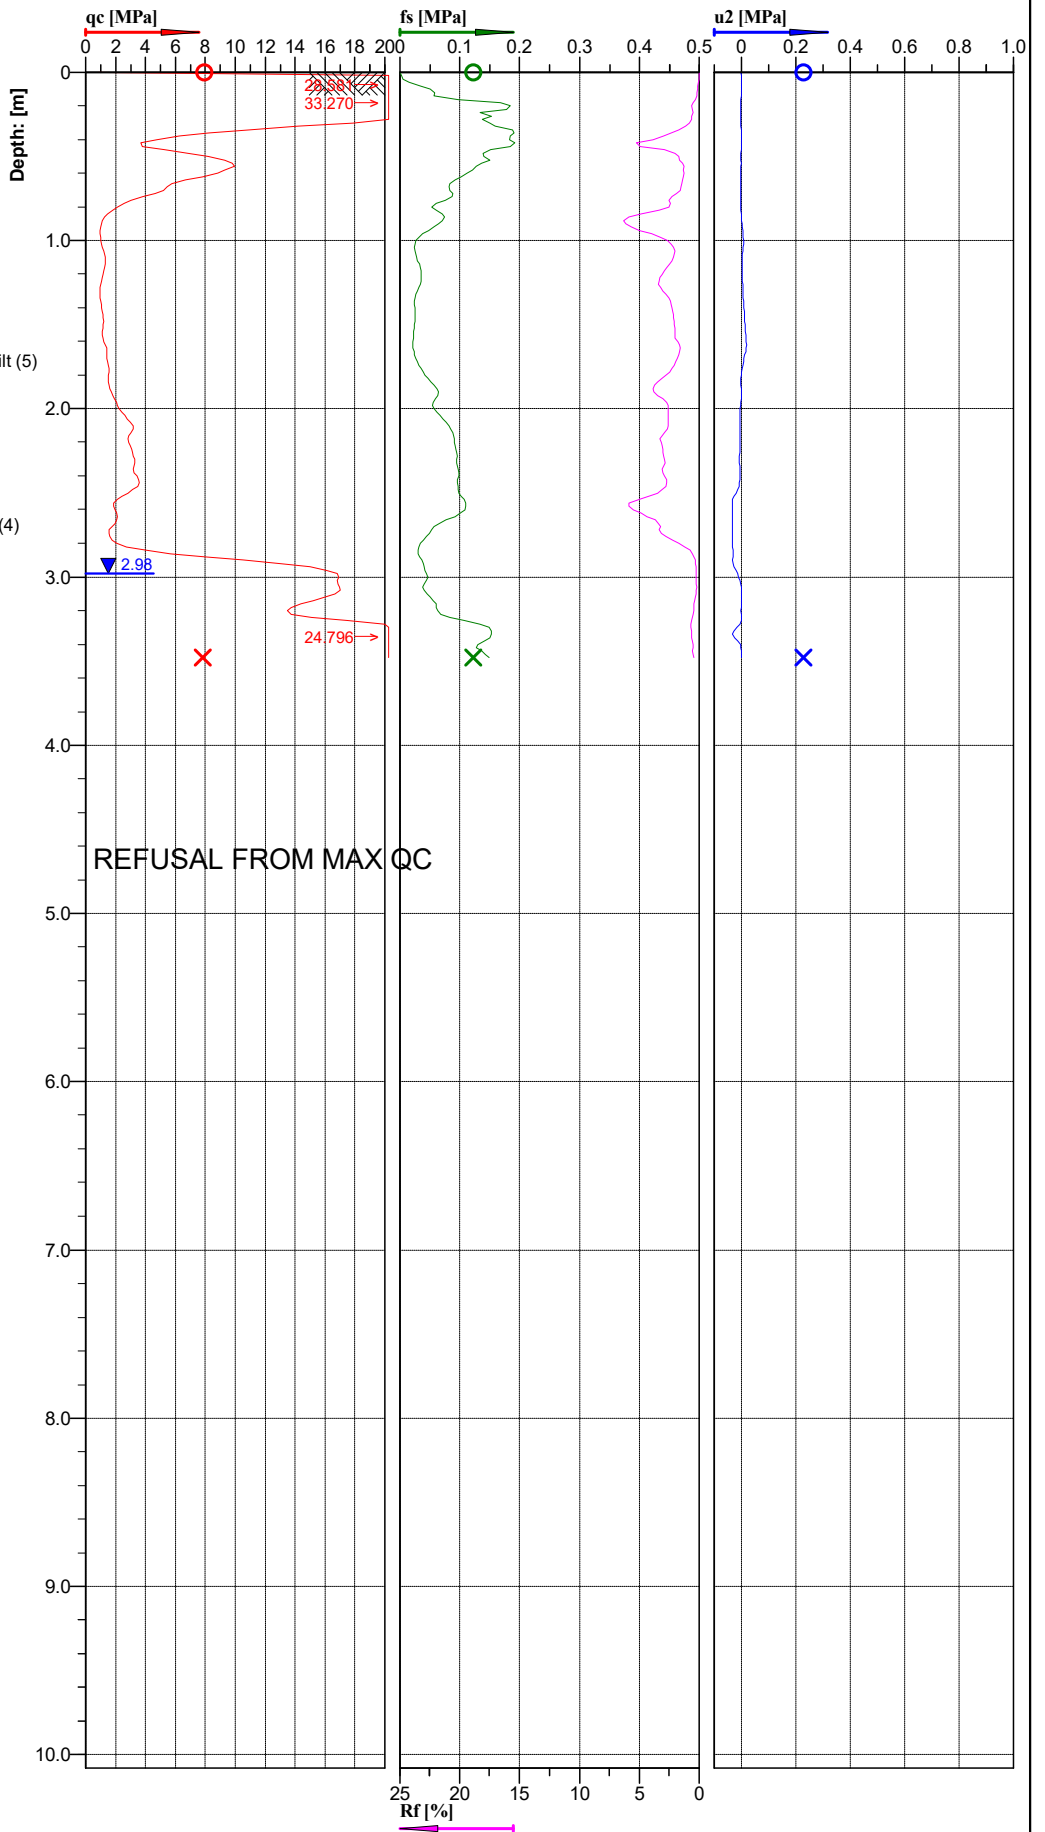
**Classification by
Robertson 1990**

Location: HAVELOCK NORTH	Position: X: 0.00 m, Y: 0.00 m	Ground level: 0.00	Test No.: CPT01
Project ID:	Client: INITIA	Date: 10/12/2020	Scale: 1 : 45
Project: BROOKVALE RESIDENTIAL		Page: 1/1	Fig.:
S 39.66121, E 176.88936			File: CPT01.cpt

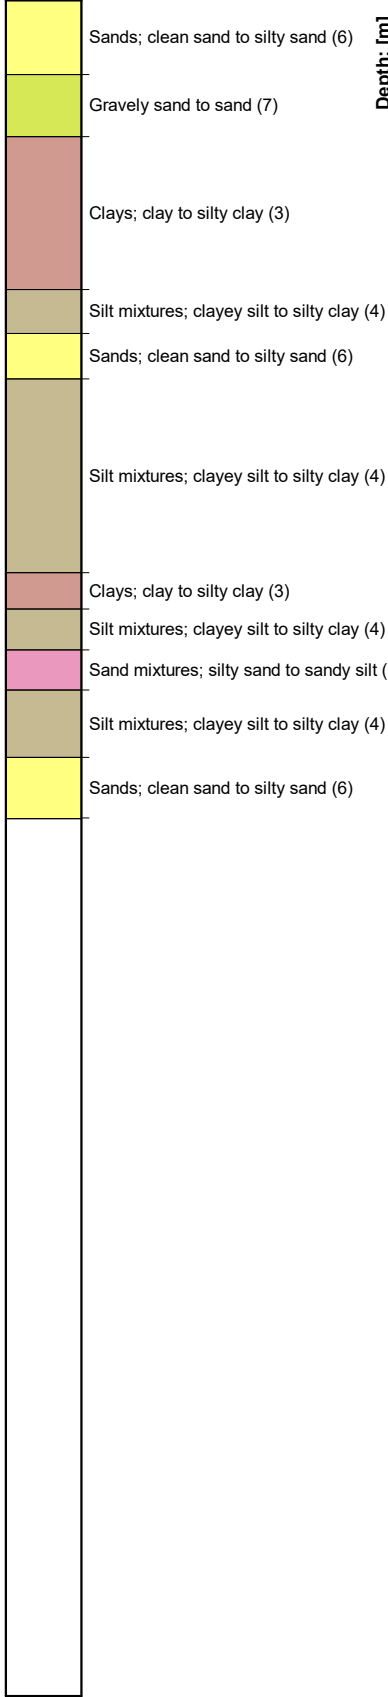
Location: HAVELOCK NORTH	Position: X: 0.00 m, Y: 0.00 m	Ground level: 0.00	Test No.: CPT04
Project ID:	Client: INITIA	Date: 10/12/2020	Scale: 1 : 45
Project: BROOKVALE RESIDENTIAL		Page: 1/1	Fig.:
S 39.66023, E 176.88980		File: CPT04.cpt

**Classification by
Robertson 1990**

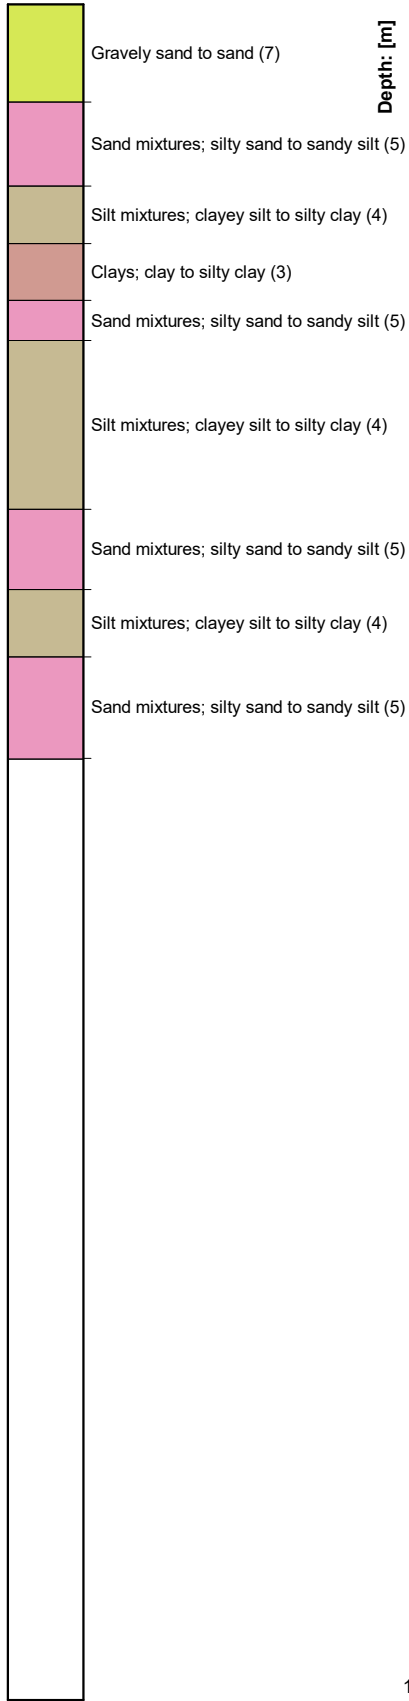
Location: HAVELOCK NORTH	Position: X: 0.00 m, Y: 0.00 m	Ground level: 0.00	Test No.: CPT05
Project ID:	Client: INITIA	Date: 10/12/2020	Scale: 1 : 45
Project: BROOKVALE RESIDENTIAL		Page: 1/1	Fig.:
S 39.66020, E 176.88951		File: CPT05.cpt

Classification by
Robertson 1990

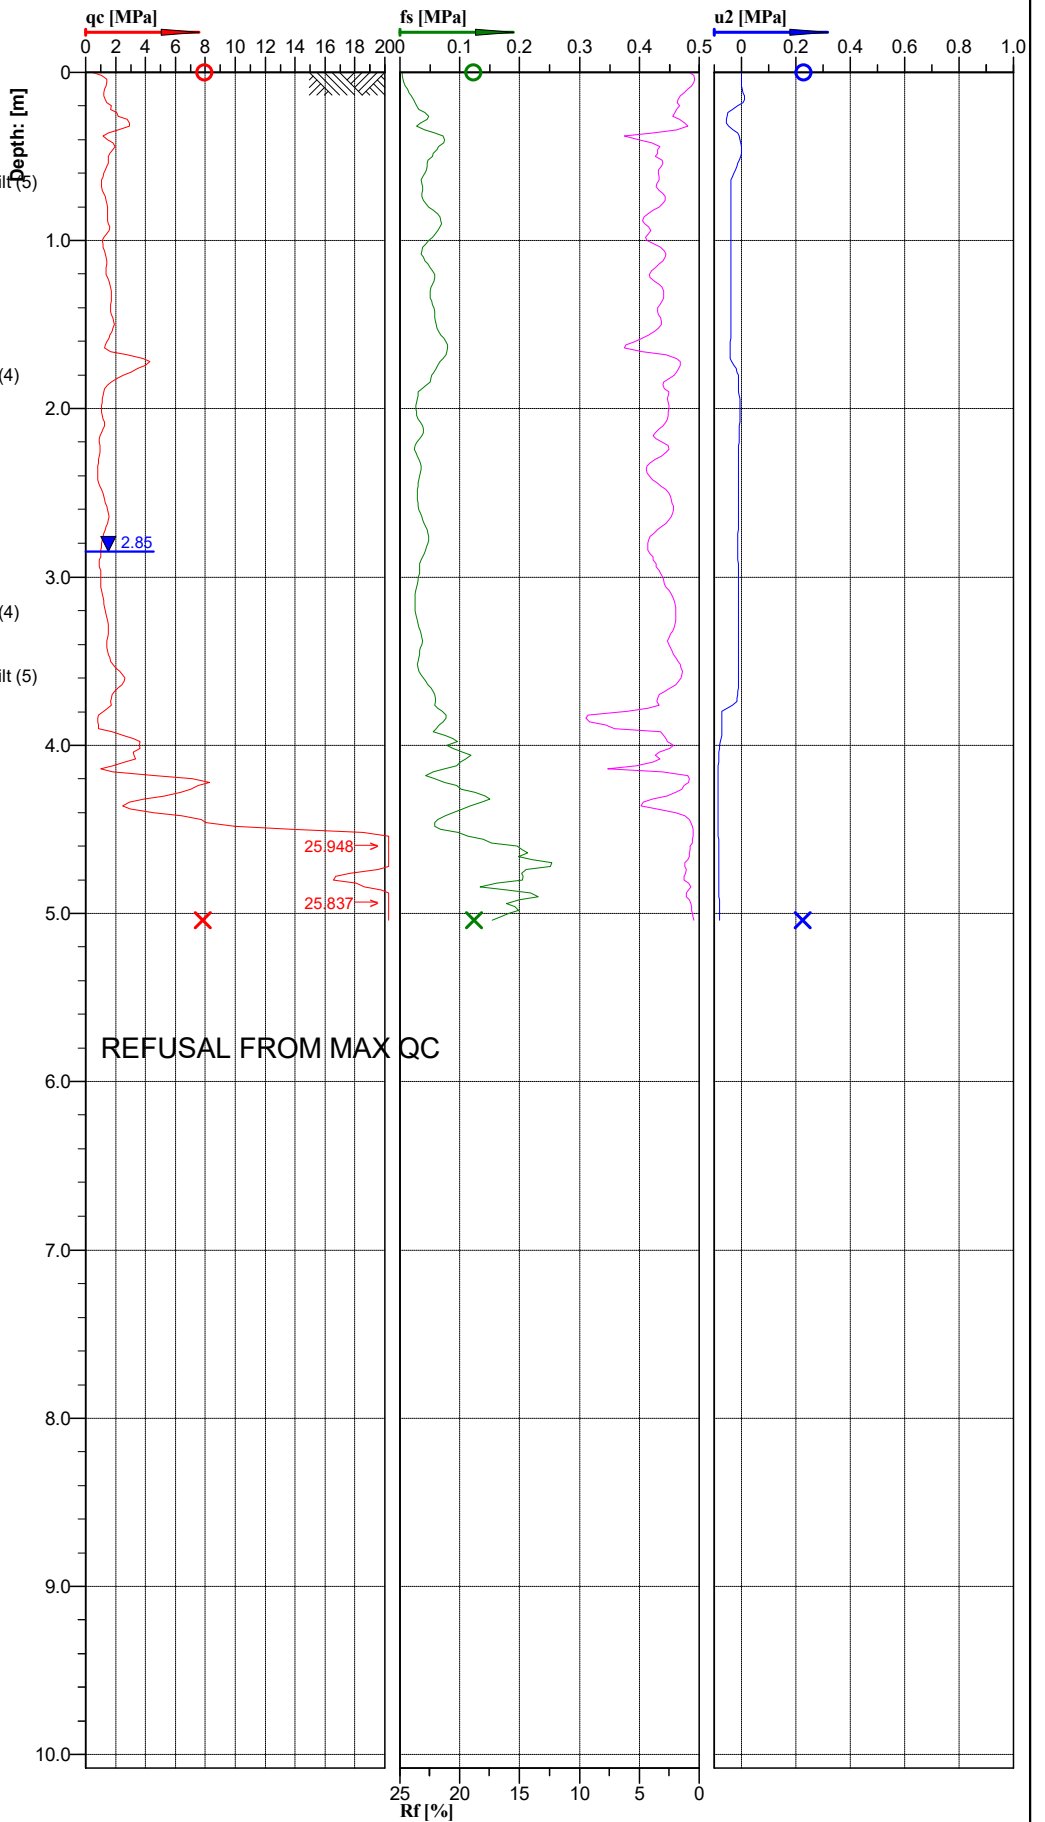
**Classification by
Robertson 1990**

Location: HAVELOCK NORTH	Position: X: 0.00 m, Y: 0.00 m	Ground level: 0.00	Test No.: CPT12
Project ID:	Client: INITIA	Date: 10/12/2020	Scale: 1 : 45
Project: BROOKVALE RESEIDENTIAL		Page: 1/1	Fig.:
S 39.66056, E 176.88887			File: CPT12.cpt
