Desktop soil and Land Use Capability classification assessment

55 Brookvale Road, Havelock North 4130

(Lot 2 DP 311724, Lot 1 DP 311724, Lot 1 DP 8274)

Prepared for: c/- Joe Gray - Saddleback
Prepared by: Dr Reece Hill - Landsystems
Report date: 21 April 2023

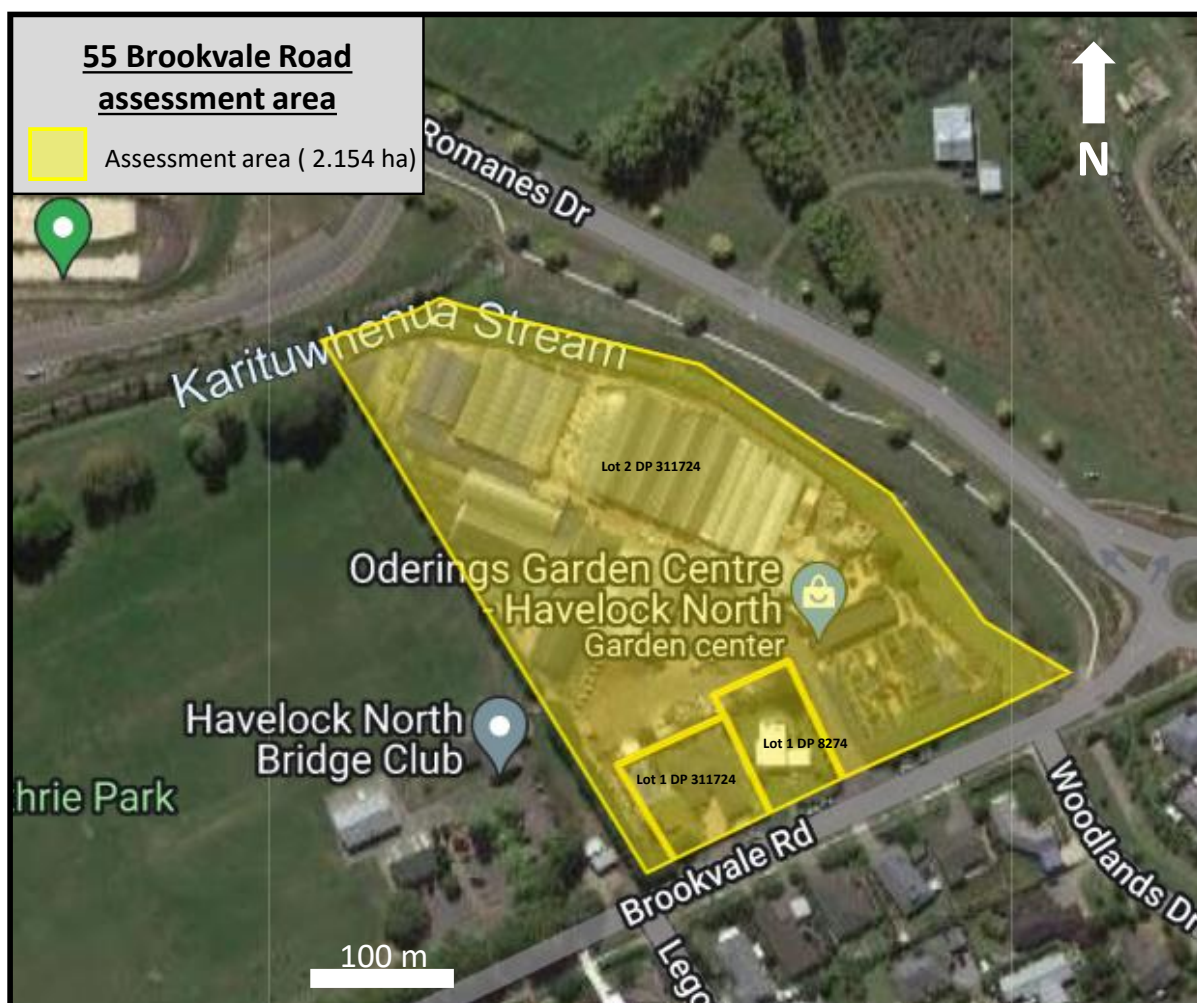
Figure 1. Soil and LUC assessment area for 55 Brookvale Road, Havelock North 4130.

A desktop soil and Land Use Capability (LUC) classification assessment of 55 Brookvale Road, Havelock North 4130 (the “Brookvale Road site”), (**Figure 1**) was undertaken to comply with the National Policy Statement for Highly Productive Land (NPS-HPL).

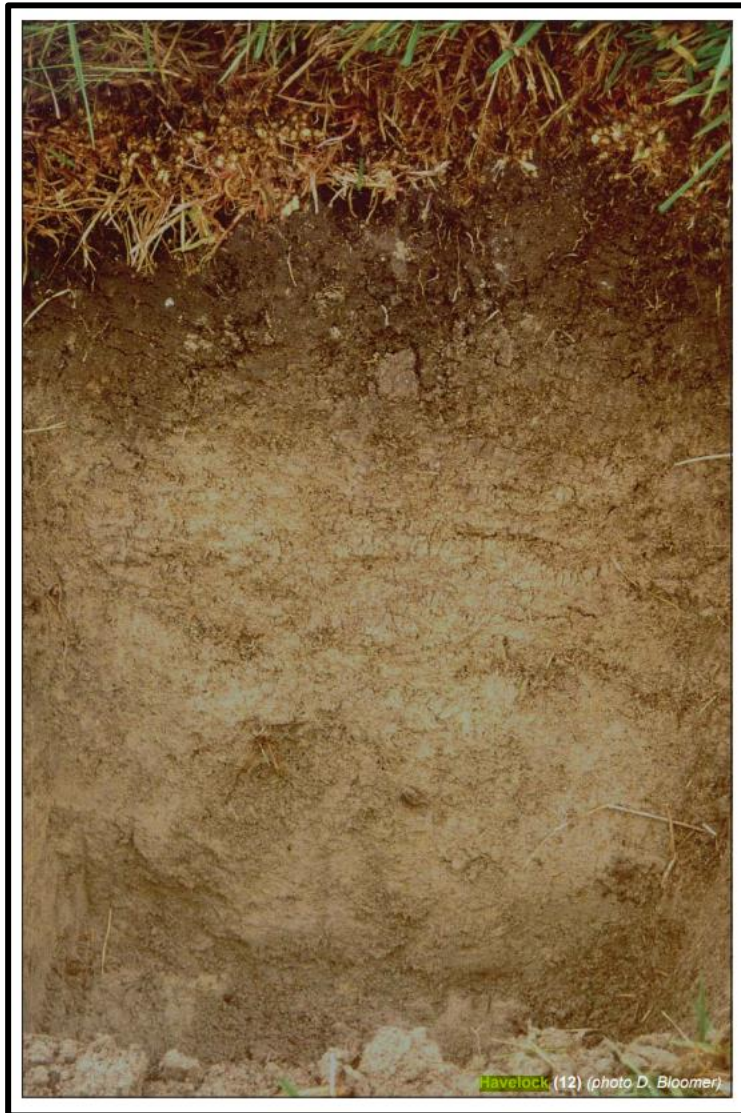
Figure 2. Example soil profile of the Havelock soil (from Griffiths, 1997)⁸.

A description of the Havelock soil properties is provided in **Appendix 1**. An example soil profile of the Havelock soil is shown in **Figure 2**.

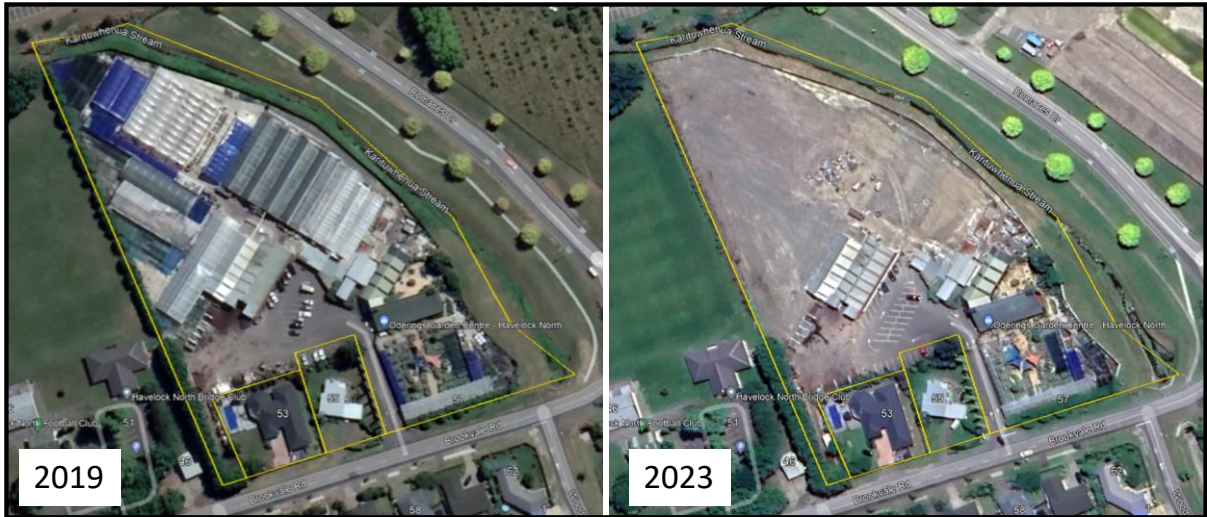
Aerial photography from 2019⁹ indicated that the Brookvale Road site had been extensively modified with nursery buildings, a garden centre, carparks, landscaped areas, recontour areas, and other buildings and dwellings (**Figure 3 (a)**).

Recent aerial photography from 2023¹⁰ indicates that in its current condition many of the buildings on the site have been removed and the site is predominantly cleared, with the exception of some remaining buildings and two dwellings and curtilage (**Figure 3 (b)**).

Figure 3. Aerial photographs of the Brookvale Road site, (a) 2019, (b) 2023.

The bore log core data and photo observations, in combination with the aerial photographs, confirms that the site has undergone modification of the original soil, including excavation of the soil, placement of fill, establishment of buildings and curtilage. The land in its current state cannot be assigned a LUC classification due to the degree of modification and is best considered non-productive land.

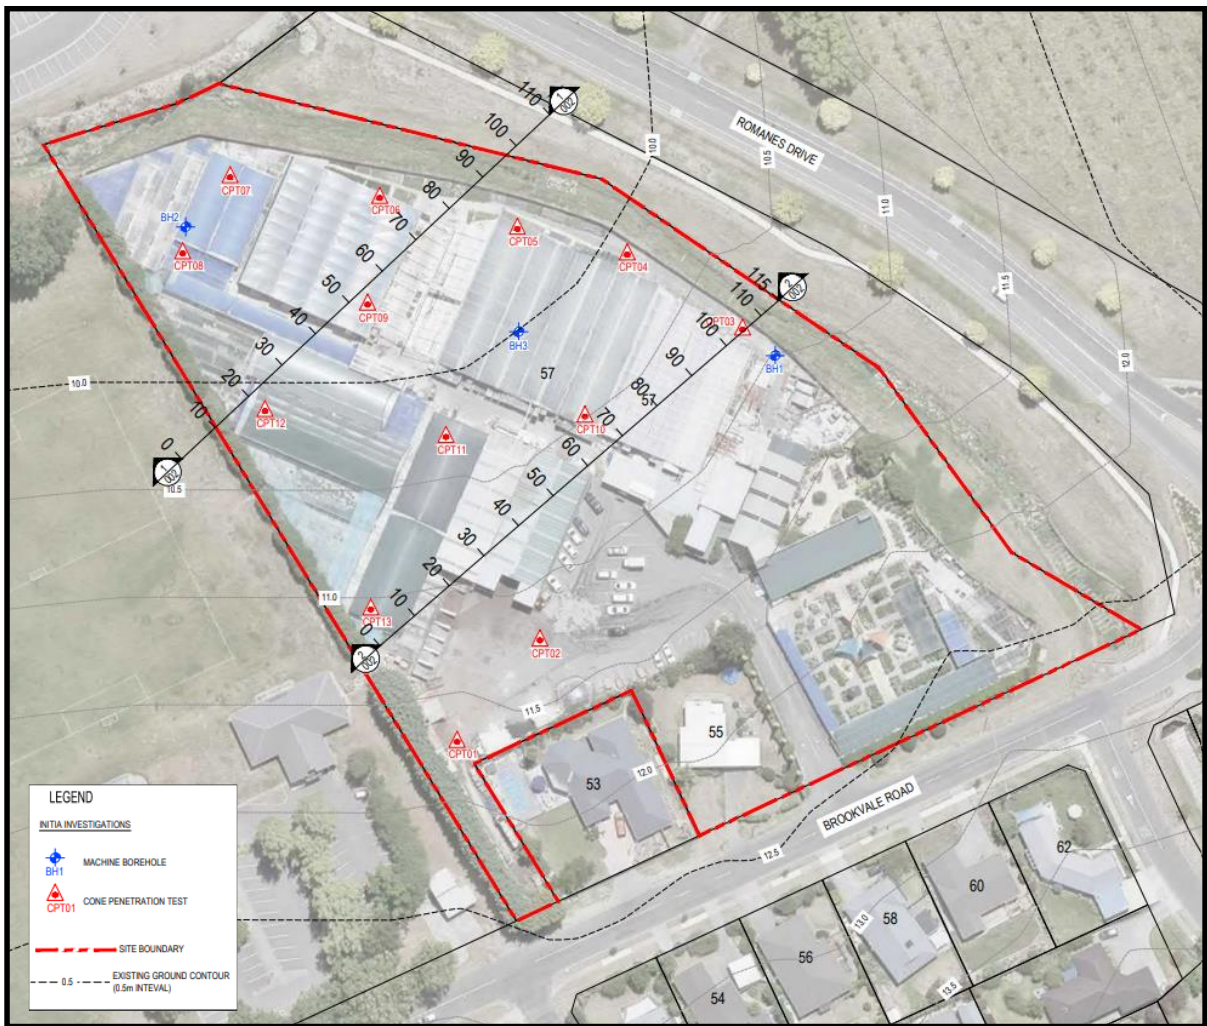
Geotechnical bore log data for the Brookvale Road site was provided by Initia Limited. The data consisted of description logs from three drilled boreholes, the locations of which are shown in **Figure 4**.

Figure 4. Drilled borehole locations on the Brookvale Road site.

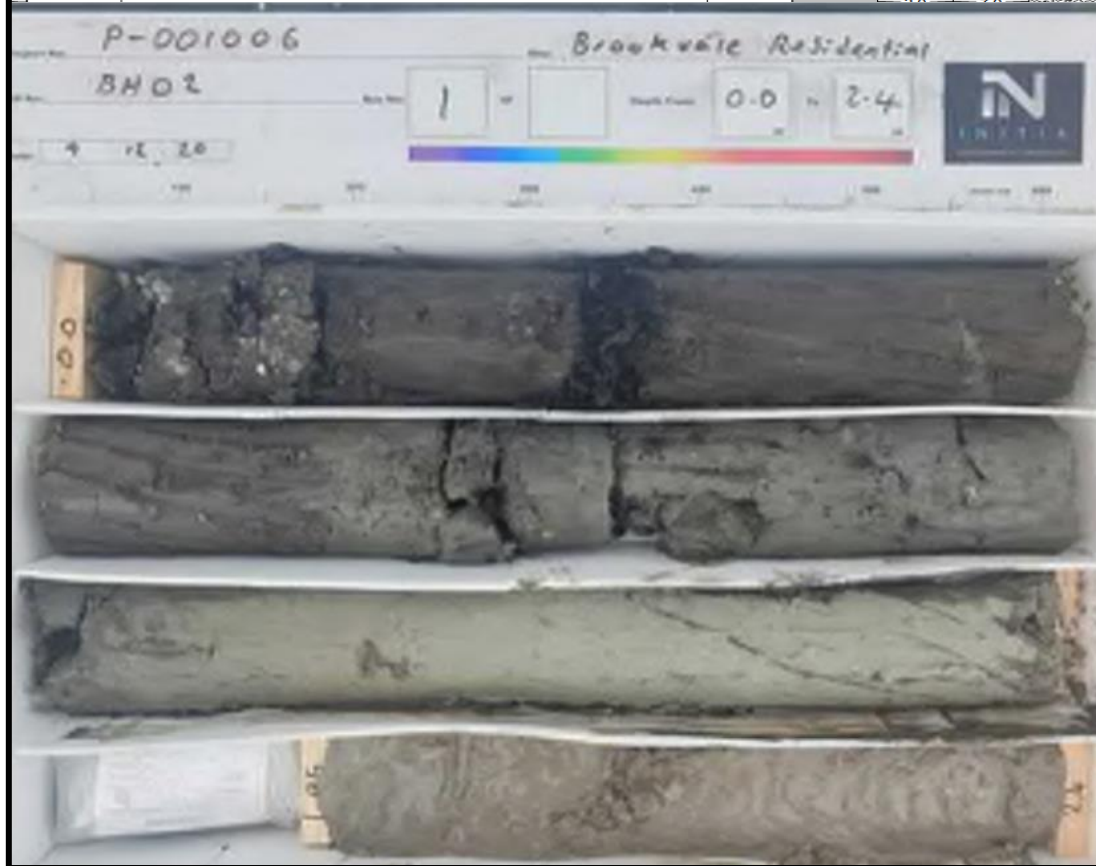
Figure 6. Upper 2.0 m detailed bore log data and photo for the for Bh2.

Bore log core number	Bore log characteristics (top 1.0 m)	Estimated LUC classification	NPS-HPL highly productive land (HPL)
1	70 cm of gravelly fill over original soil profile, with silty topsoil and greyish brown silty sandy gravel.	Modified soil – classified as non-productive land. Not LUC 3s6.	Not HPL
2	20 cm of dark grey silty sand fill over dark brown to greyish brown silt.	Not LUC 3s6 Underlying poorly drained soil material.	Not HPL
3	75 cm silty gravel fill (core loss underlying).	Modified soil – classified as non-productive land. Not LUC 3s6.	Not HPL

The inferences that can be made from the cores is somewhat limited as they only provide a few points of observation across the site. However, all three LUC cores showed fill overlying soil material. Of the three cores, BH1 possibly had soil material underlying the fill that resembled soil material similar to the Havelock soil. The other two cores did not, and most likely had original soils that were poorly drained.

The presence of fill in the upper 20-75 cm of the cores indicated that the original soil at all three cores had been modified, with placement of fill and possibly some excavation before placement.

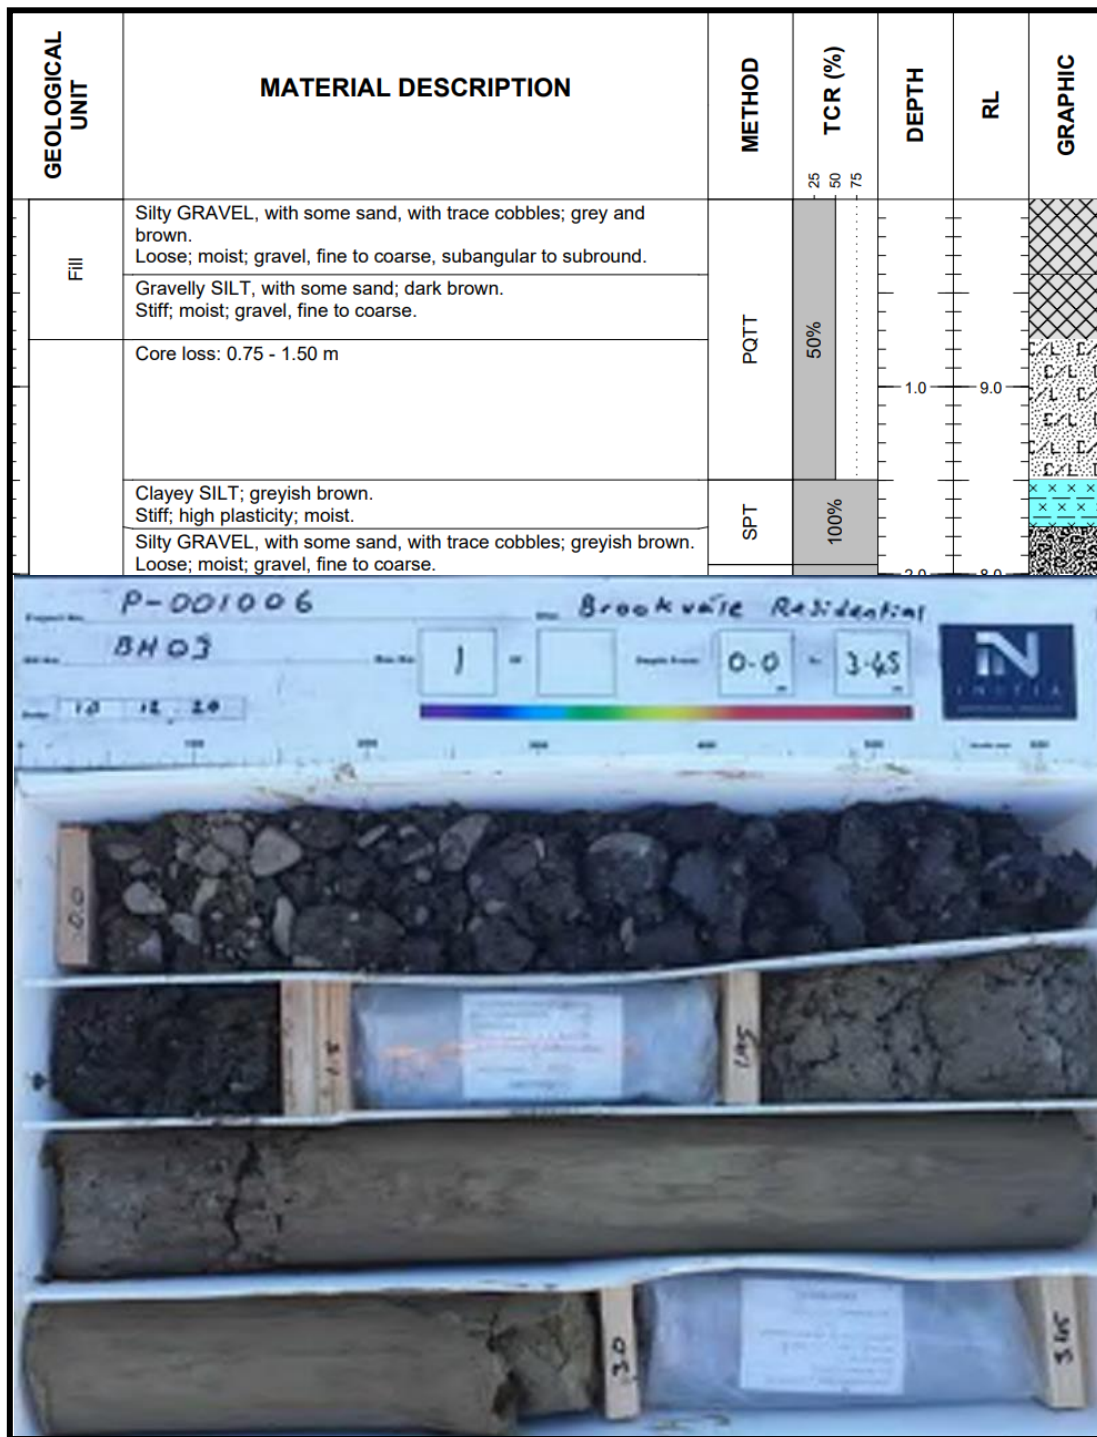
Figure 7. Upper 2.0 m detailed bore log data and photo for the for Bh3.
