Appendix K: Hydrogeology Report

Omarunui Landfill Area B
Hydrogeological Assessment Report -
For Notification

Prepared for
Hastings District Council

Prepared by
Tonkin & Taylor Ltd

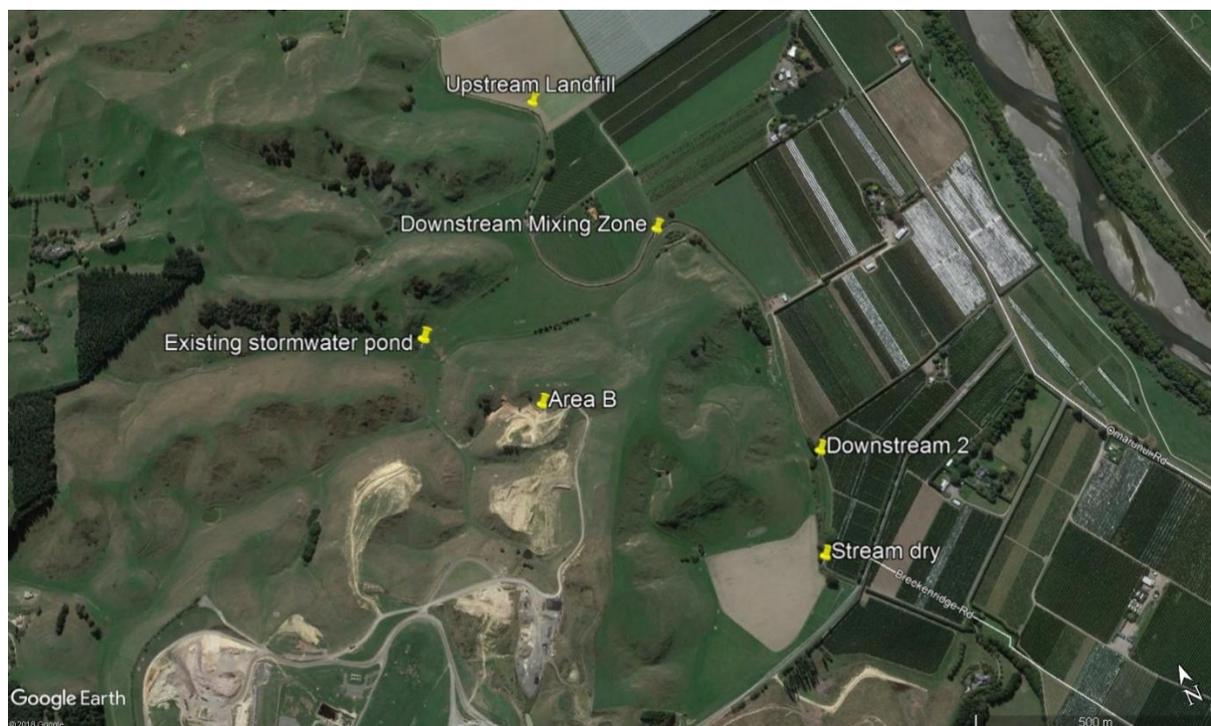
Figure 2.1: Aerial image of the Omarunui Landfill showing the three sampling sites visited on 26 February 2018 and the location of the dry area of stream bed ('stream dry') further downstream (Source: Google Earth).

A site visit was completed on 26 February 2018 during fine weather conditions. Three sites were assessed on the Upokohino Stream: one upstream of the landfill, one downstream of the likely mixing zone for the proposed stormwater discharge and one downstream of the landfill site (Figure 2.1)

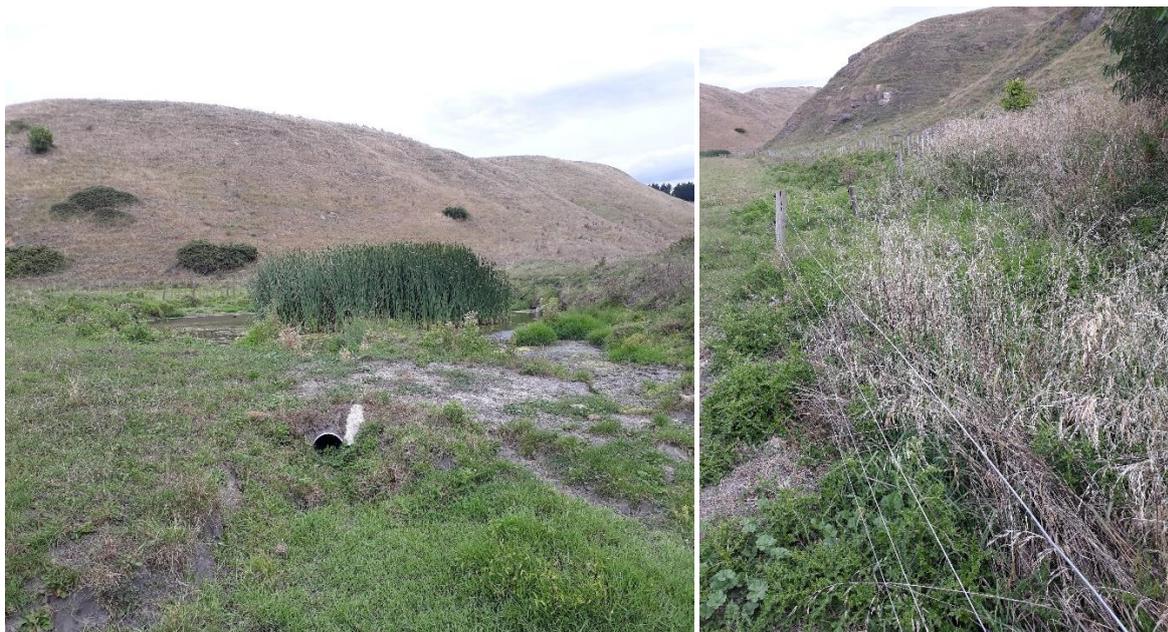
Photograph 4.1: From left to right: the existing pond at the downstream end of Area C, and the unnamed farm drain leading to Upokohino Stream (looking upstream towards pond).

Runoff from Area B and C discharges to an existing pond on the neighbouring property downstream and subsequently to the Upokohino Stream (Figure 4.1 and Photograph 4.1). The proposed stormwater treatment pond and wetland for Area B would be in the vicinity of the existing pond as described in Section 3.2.2.

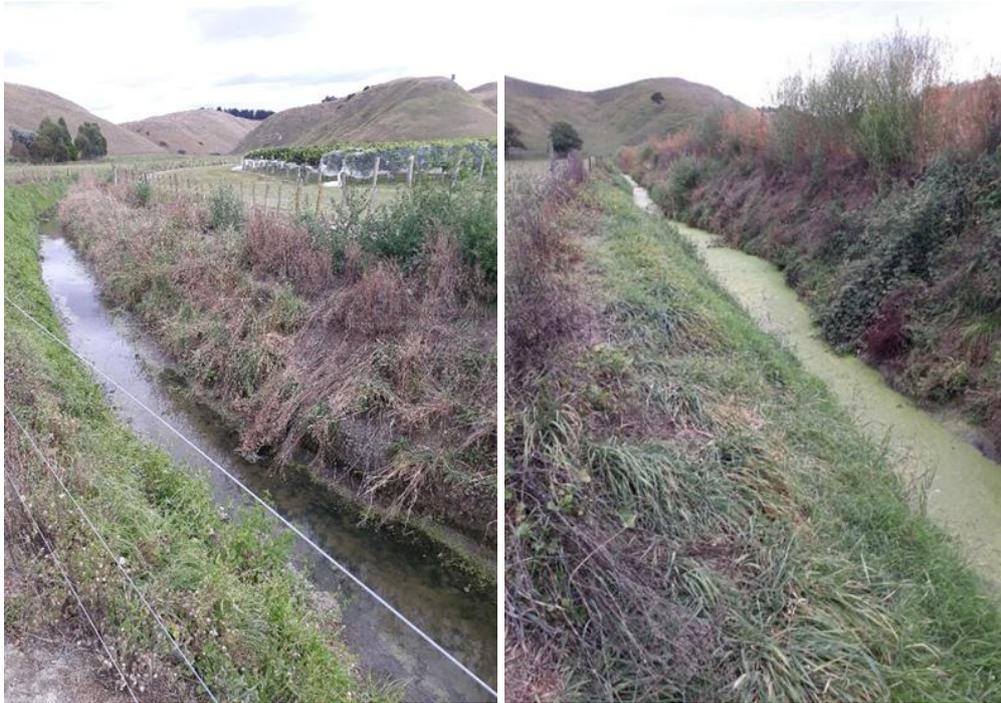
Photograph 5.2: From left to right: Omarunui Upstream Landfill sample site (looking upstream) and Downstream Mixing Zone sample site (looking upstream).

The Upstream Landfill site is located approximately 350 m upstream of the stormwater discharge point (Photograph 5.2). The stream bed comprised a thick layer of mud and decomposing aquatic weeds, and the stream was choked with a dense growth of macrophytes (likely *Lemna minor*). An eel was disturbed at this site. The average stream depth was approximately 0.15 m.

The Downstream Mixing Zone site is approximately 320 m downstream of the proposed stormwater discharge point (Photograph 5.2). Stormwater discharge from the Area C valley also enters at this discharge point. The stream bed comprised a thick layer of mud, and there was very little growth of macrophytes (likely *Lemna minor*). There were patches small of cyanobacteria mats on the sediments. The average stream depth was approximately 0.1 m.

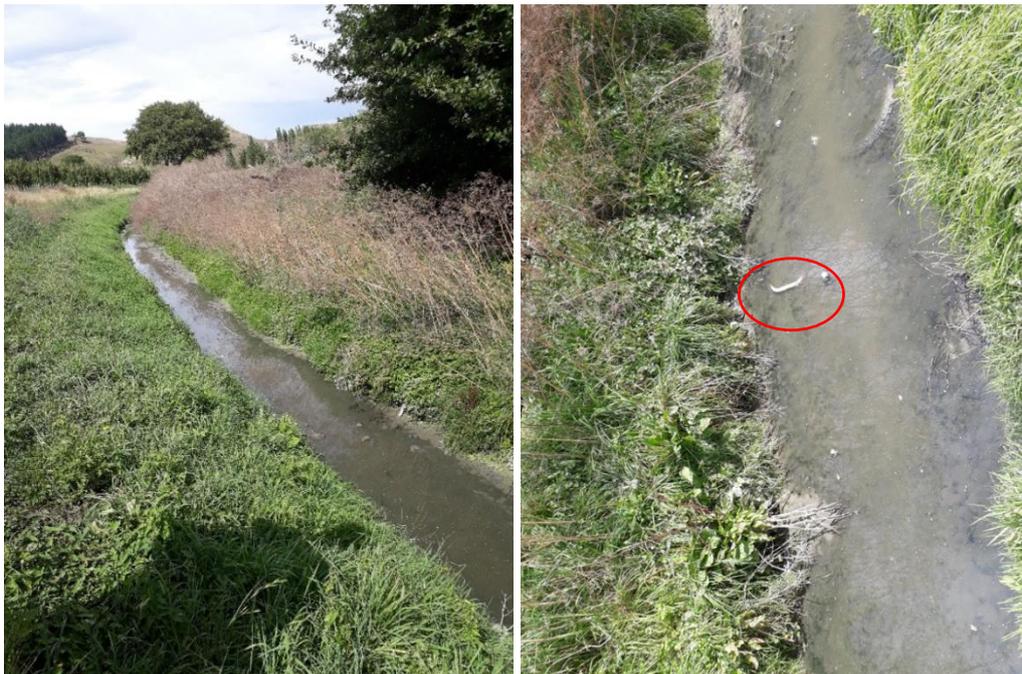
Photograph 5.3: From left to right Omarunui Downstream 2 sample site (looking downstream) and dead eel (circled) at the Downstream 2 site.

This site is downstream of the Downstream Mixing Zone site, approximately 970 m downstream the proposed stormwater discharge point (Photograph 5.3). Two dead eels were observed at the sample site, and two live eels (< 300 mm) were observed swimming up and down a short section of stream. The average stream depth was approximately 0.1 m.

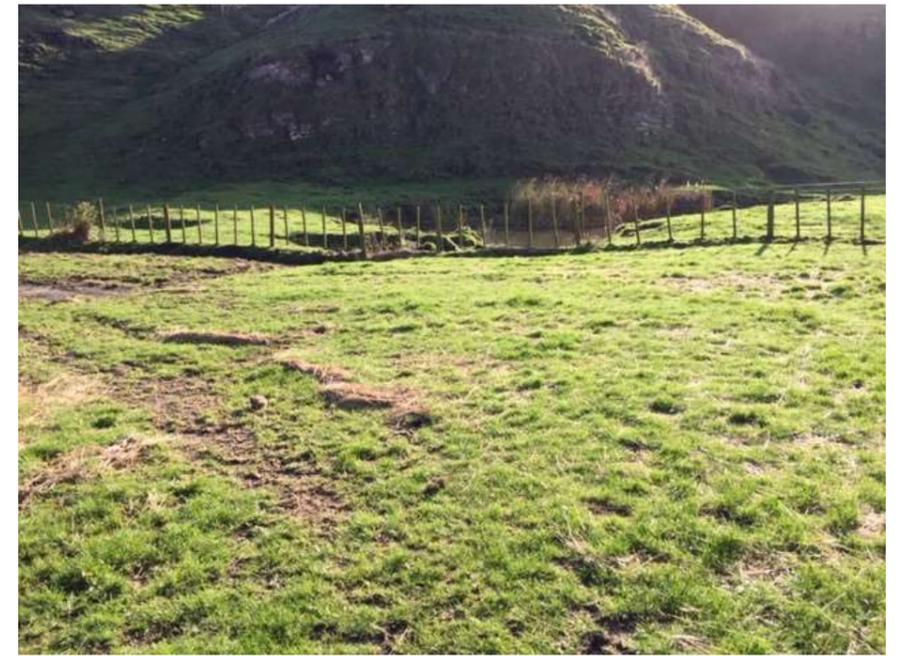
Photo 6 towards the pond / wetland

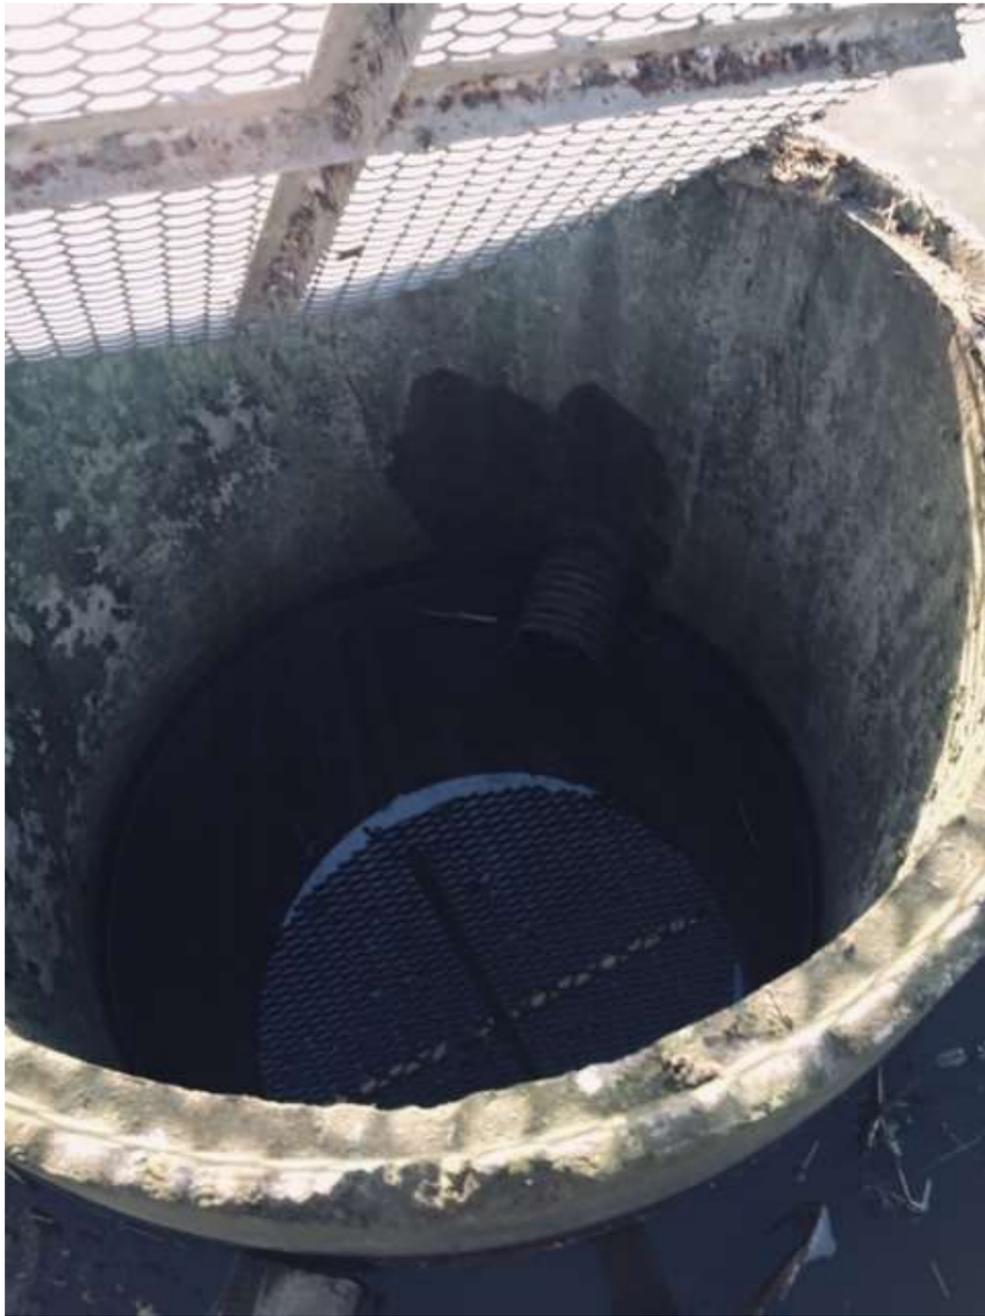
Photo 7 900 mm dia Manhole culvert and runs to the Upokohino Stream.

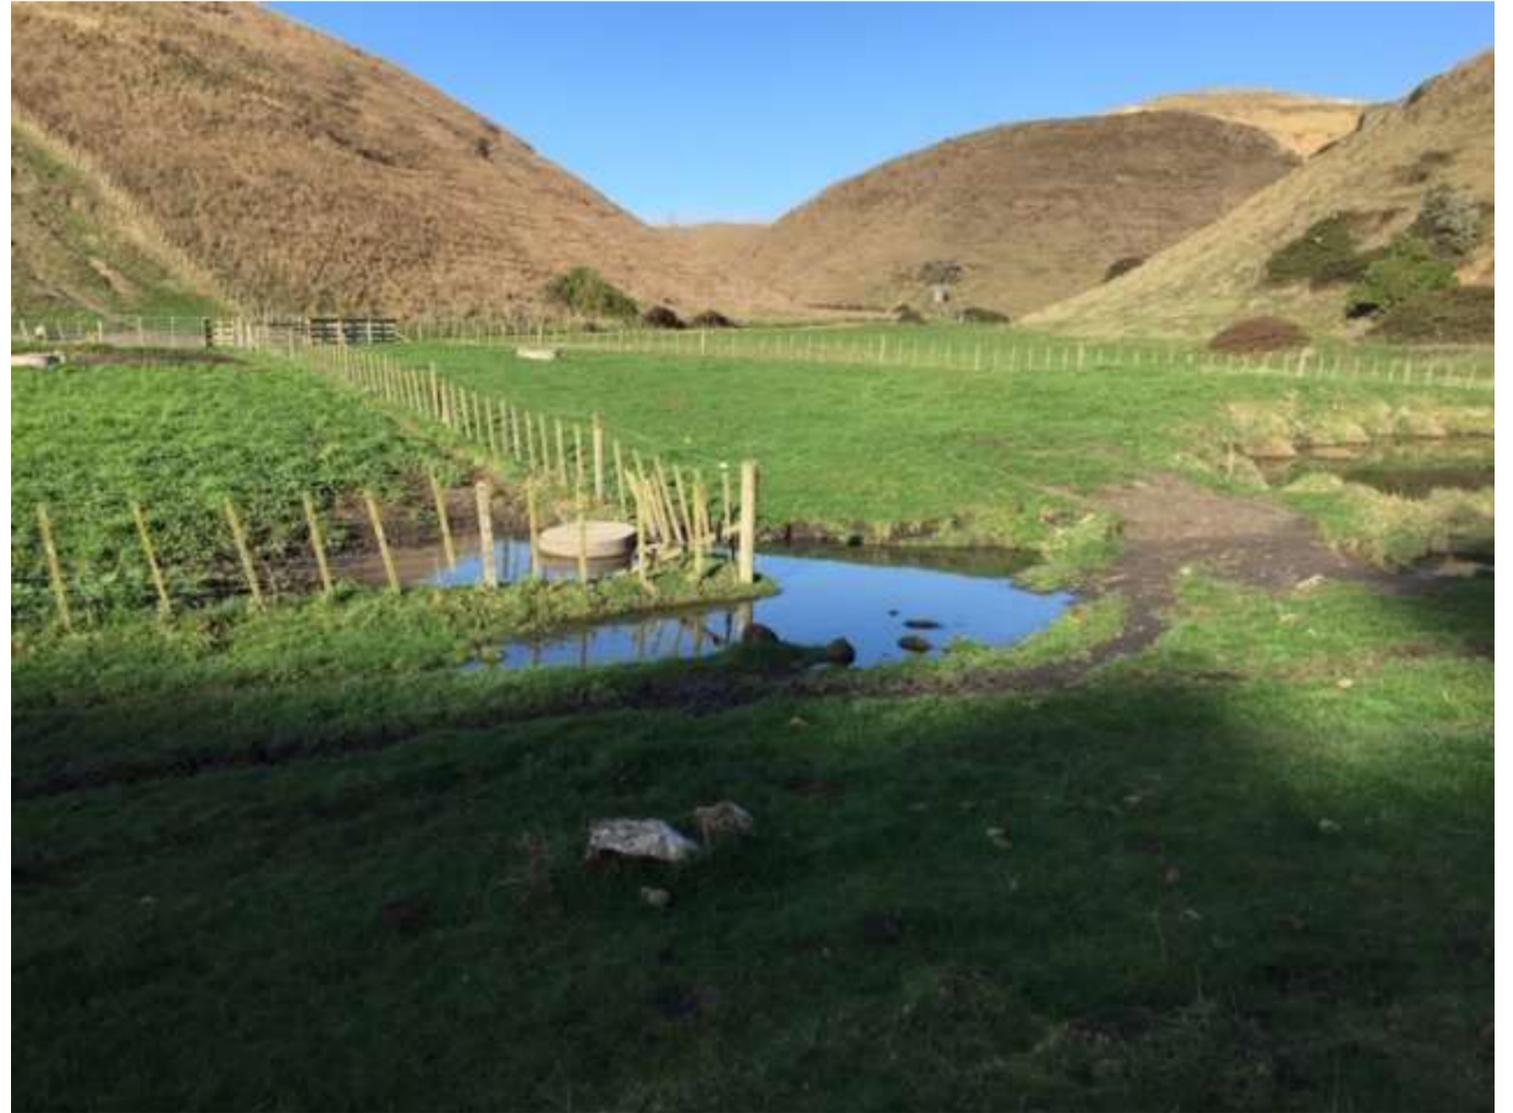
Photo 9 Looking at Manhole back towards Valley B, C the and runs to Upokohino Stream.

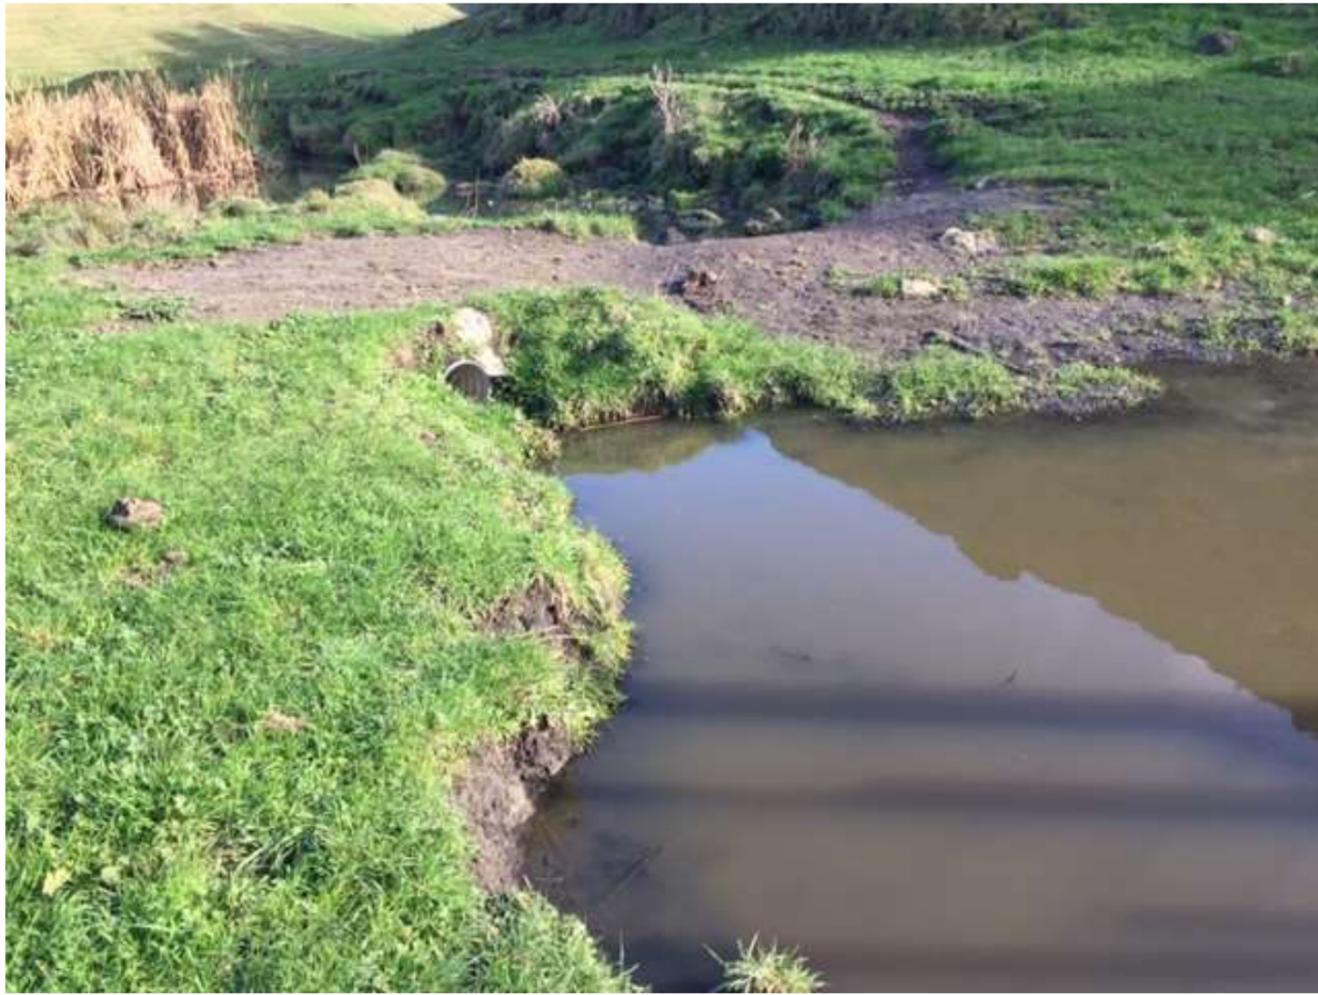
Photo 8 Small steel helicoil culvert between Pond / wetland and the small pond which feed the Manhole

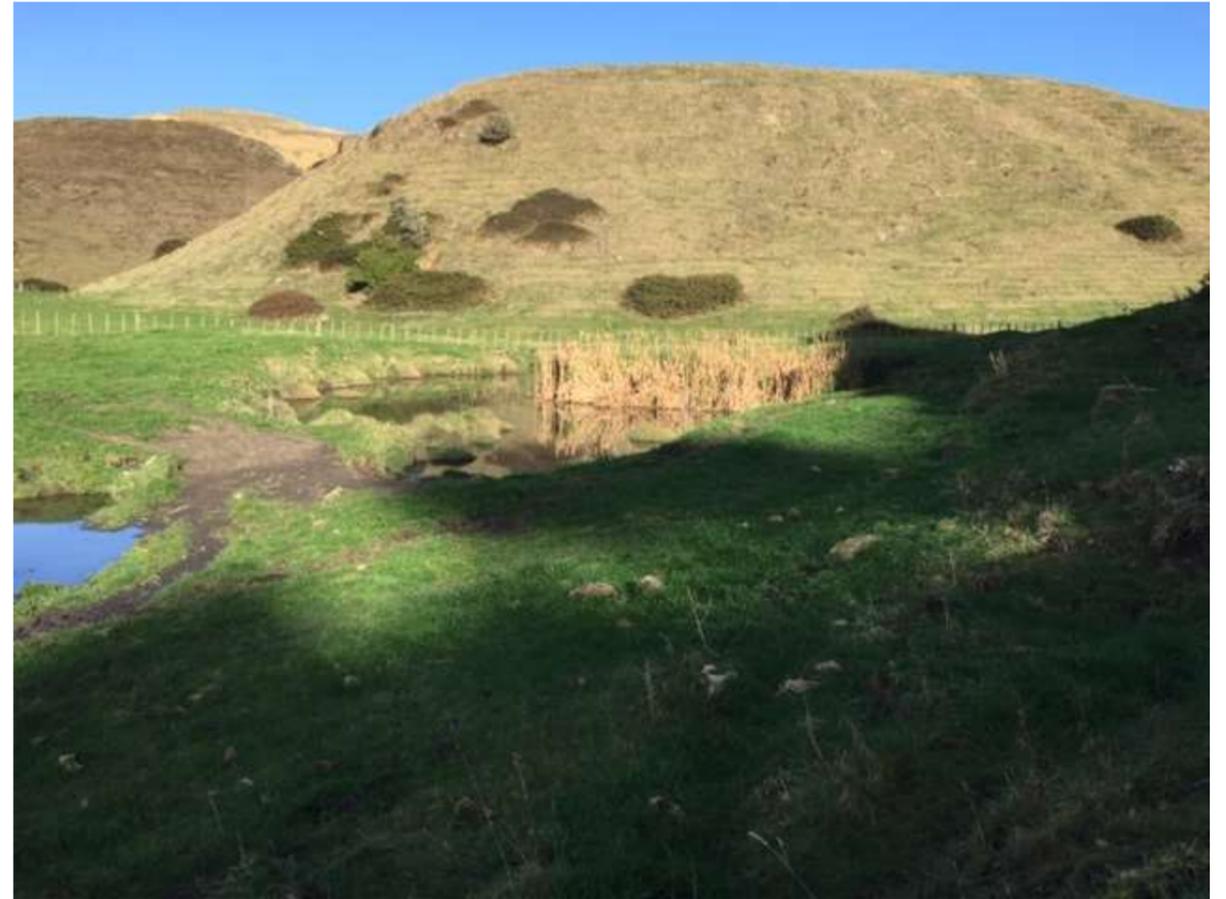
Photo 10 Wetland, Culvert and small pond which feeds Man hole.

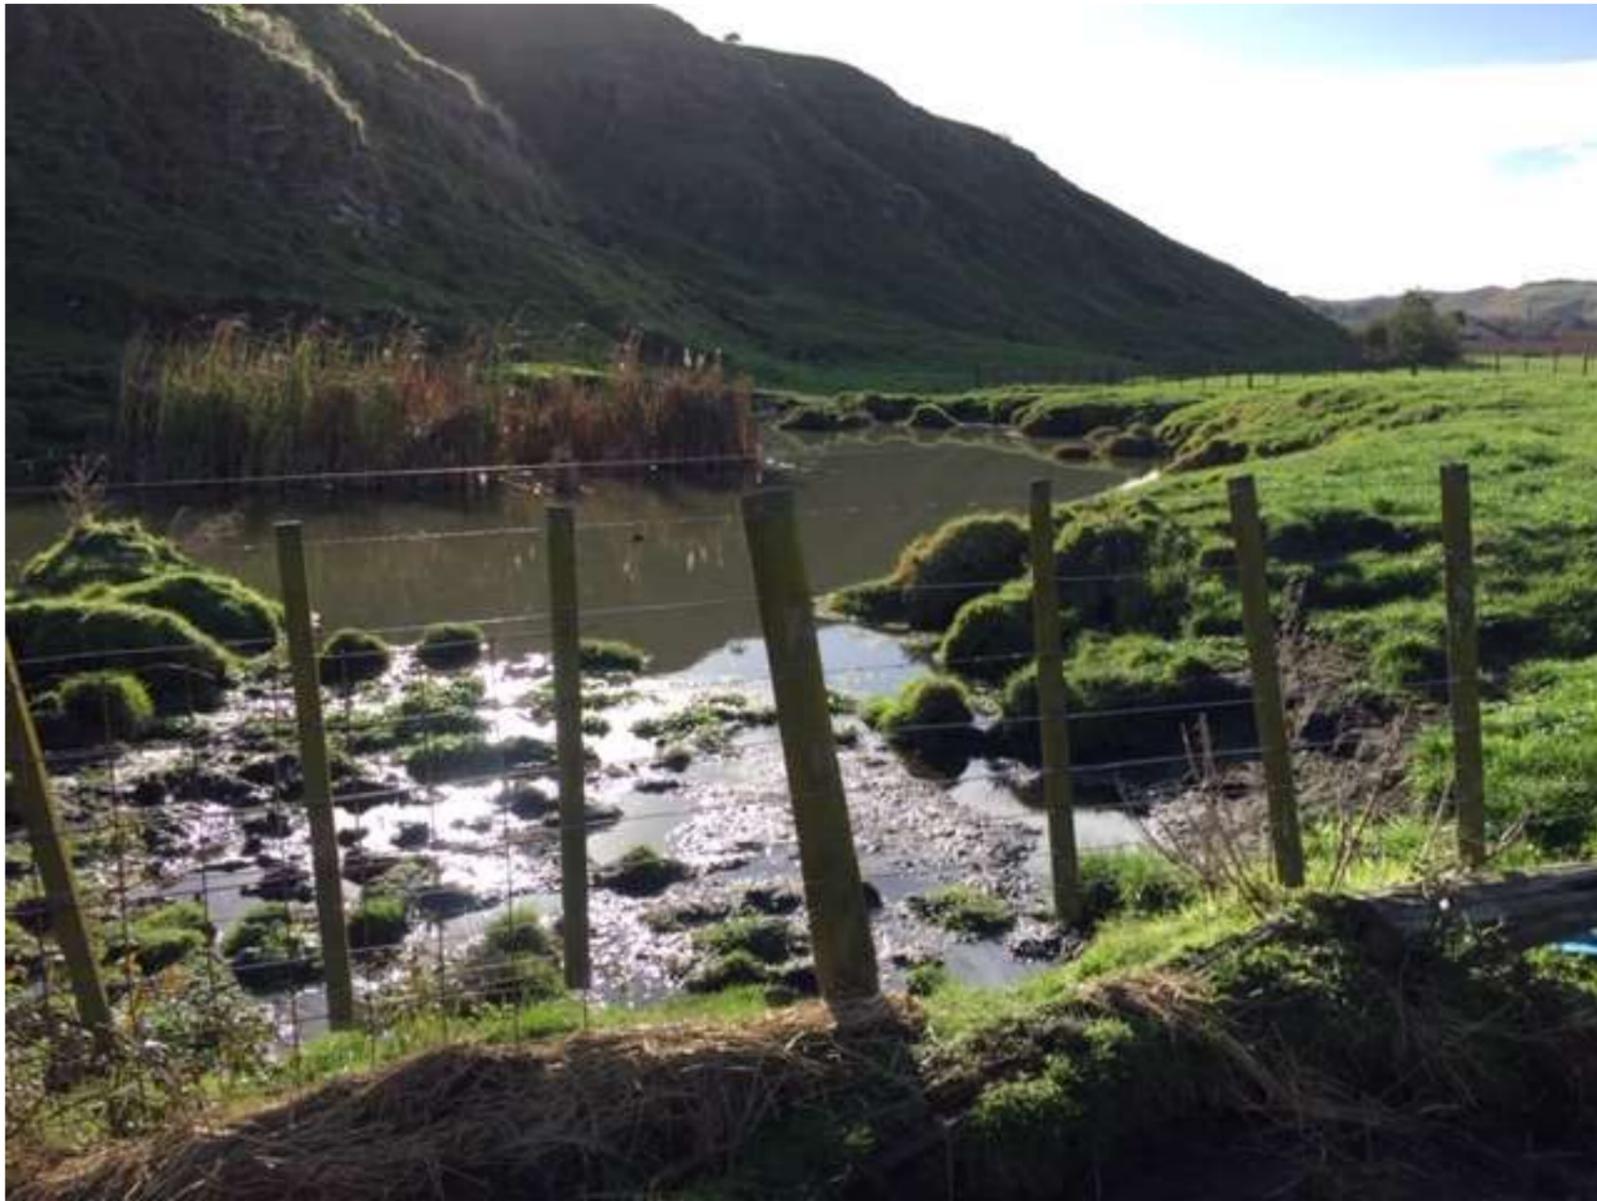
Photo 11 looking north at wetland

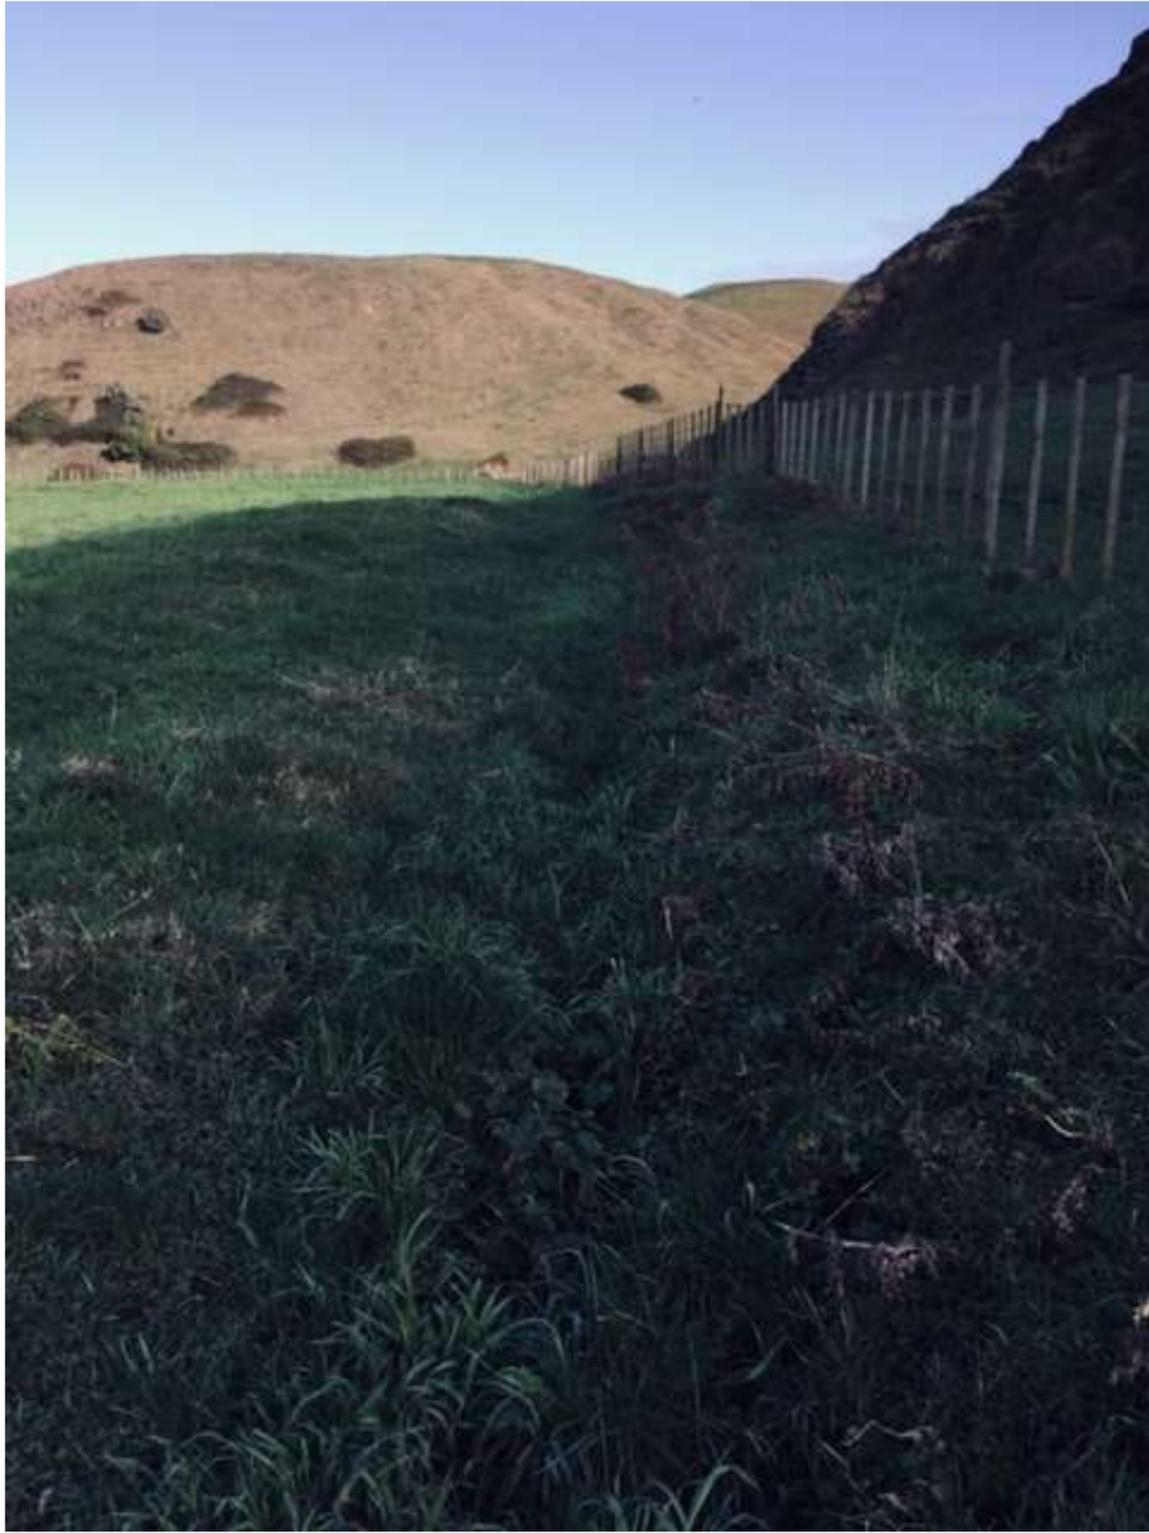
Photo 13 Looking south back up valley this is the small open ditch which runs down the valley

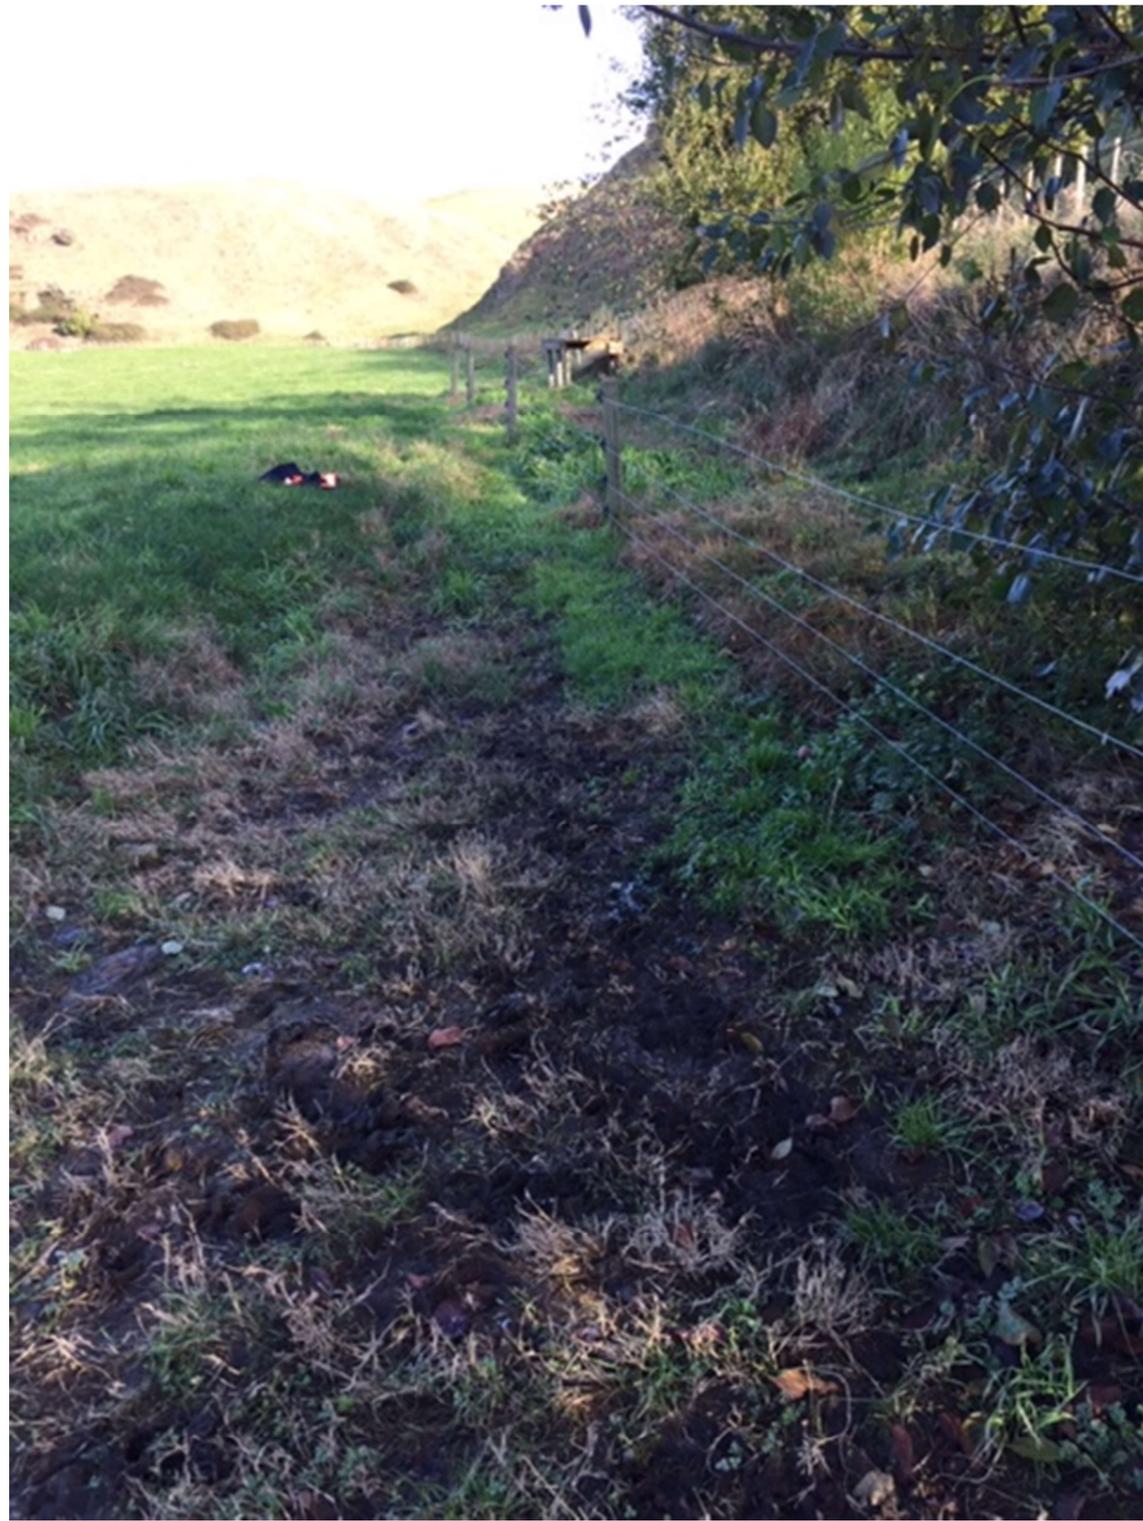
Photo 14 Looking south back up valley this is the small open ditch which runs down the valley

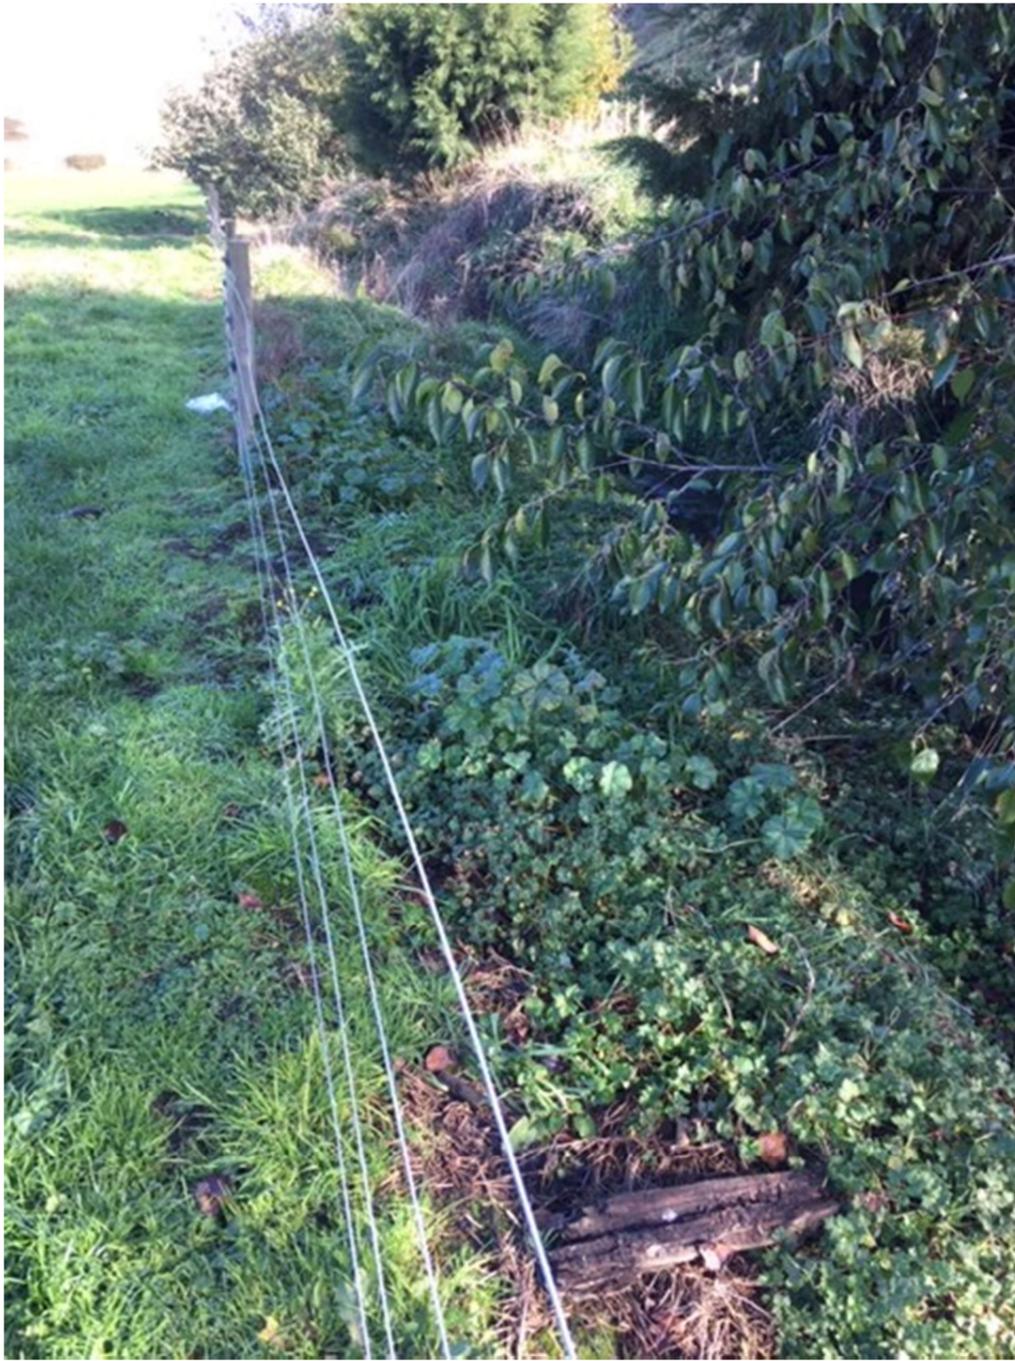
Photo 15 Looking south back up valley this is the small open ditch which runs down the valley
And into a small vegetated area

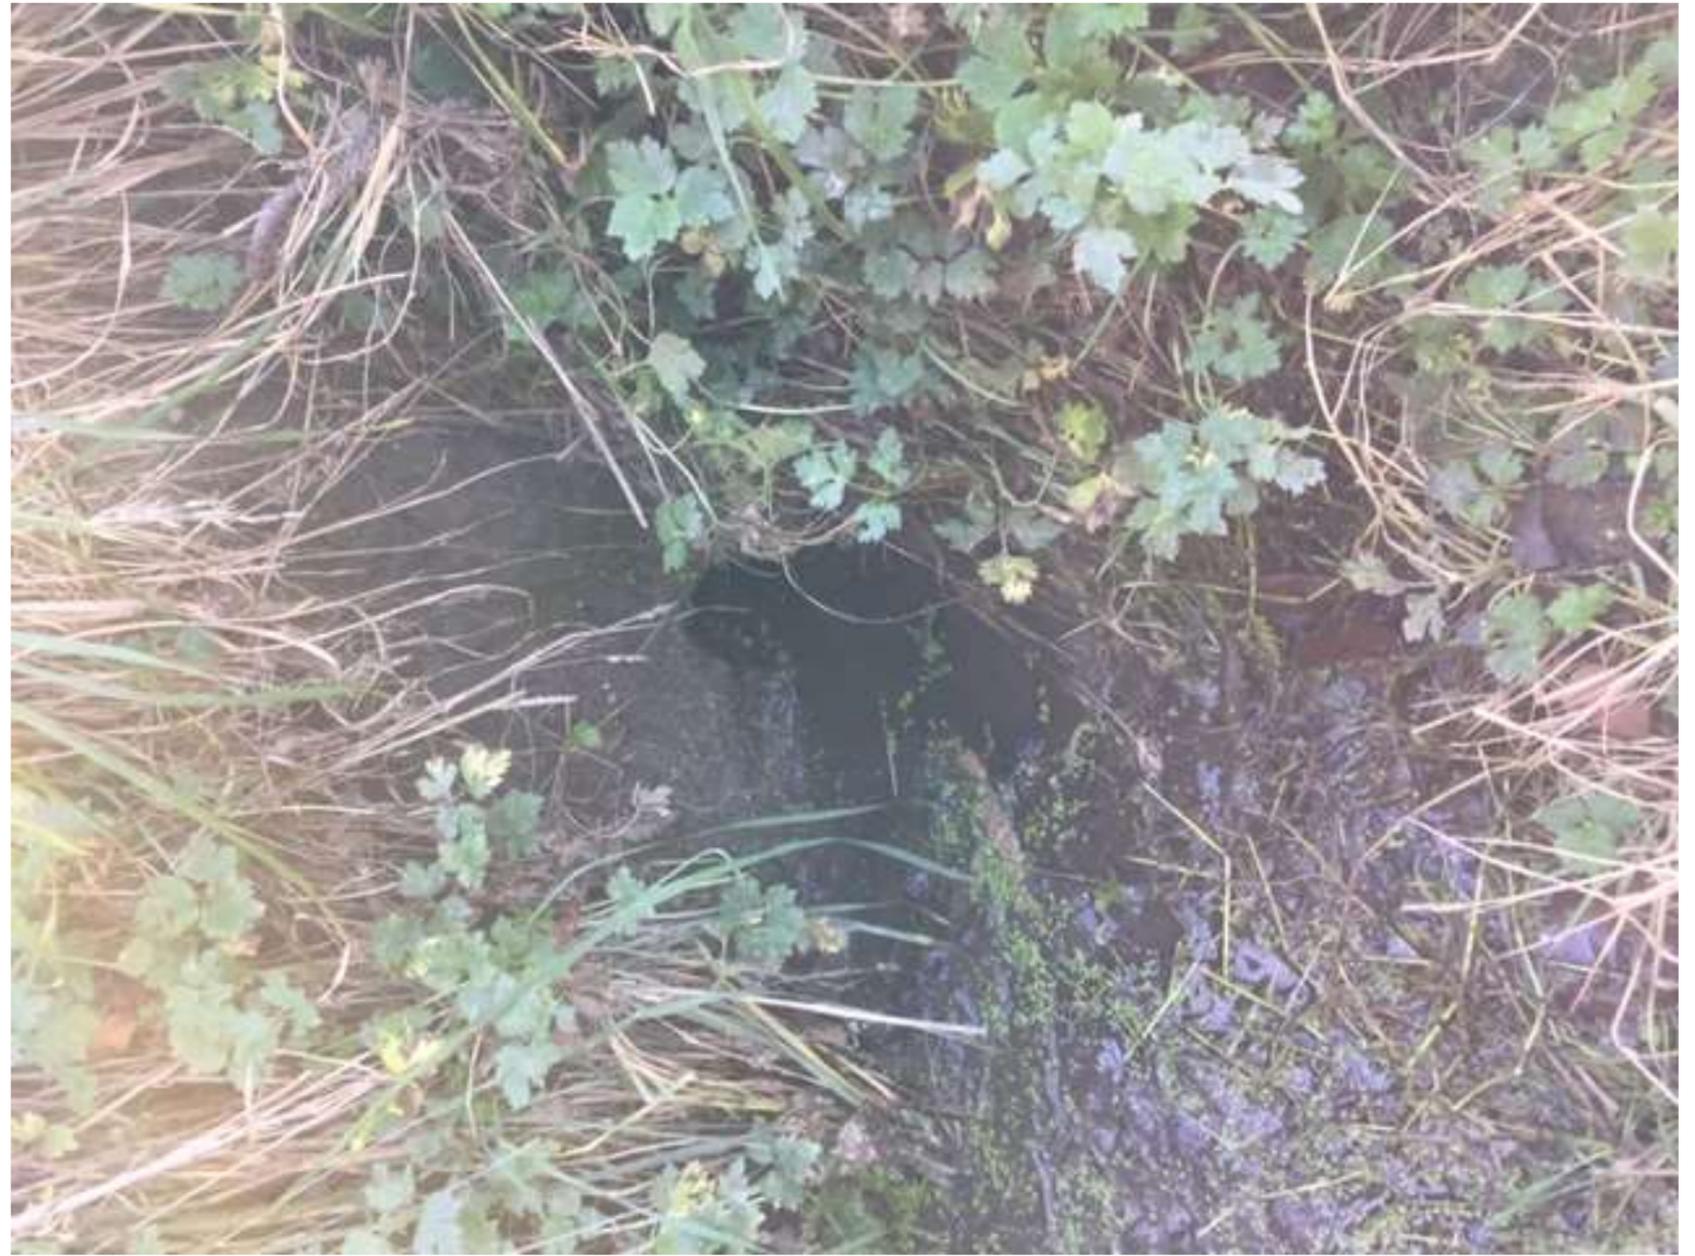
Photo 16 this is the end of the open drain next to photo 15 water then runs into a 100 mm Dia there is no over land drain from here this is were
the water runs through to the Upokohino Stream

A layout sketch and accompanying photographs of the farm drain system is provided in Appendix A. In summary, the farm drain system comprises a combination of 100 mm diameter sub-soil pipe sections and open drain. The open drain terminates around 50 m upstream of the Upokohino Stream with another 100 mm diameter section leading to Upokohino Stream. The system conveys flows from the whole of the valley (which includes the Area B). During dry weather there is unlikely to be flow or water consistently present in the open section of the Farm Drain. During rain events some catchment runoff (including the discharge) will discharge to the Upokohino Stream via the two sub-soil pipes and some via overland flow. Given this discharge scenario we consider that Upokohino Stream is more relevant to consider as the receiving environment.

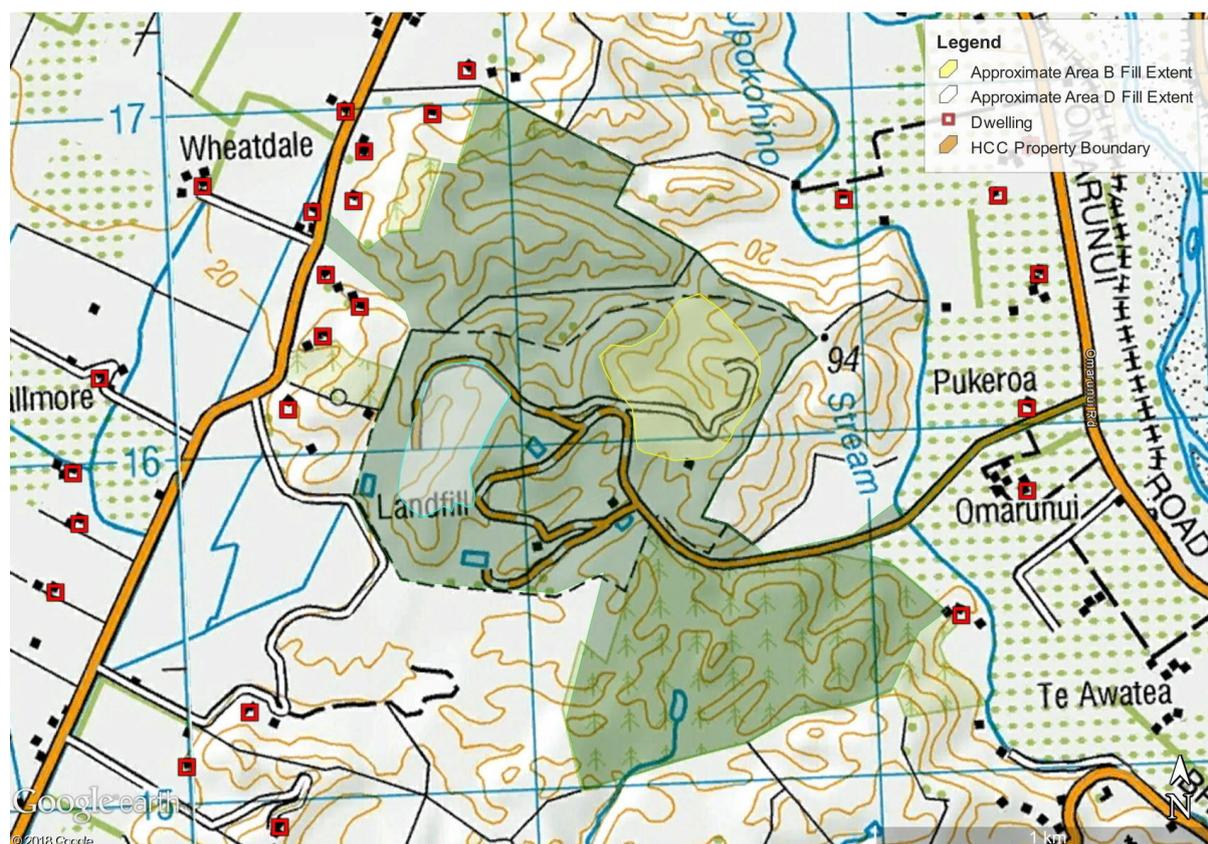
Figure 4.2: Topography of landfill site and surrounds

The topography of an area can influence wind and air flow and therefore the dispersion of emitted contaminants. The topography of the site and locality is illustrated in Figure 4.2.
