DETAILED SITE INVESTIGATION

147-151 NAPIER ROAD
HAVELOCK NORTH

PROJECT NO. EAM2313-01

PREPARED FOR
SUN PROPERTIES LIMITED

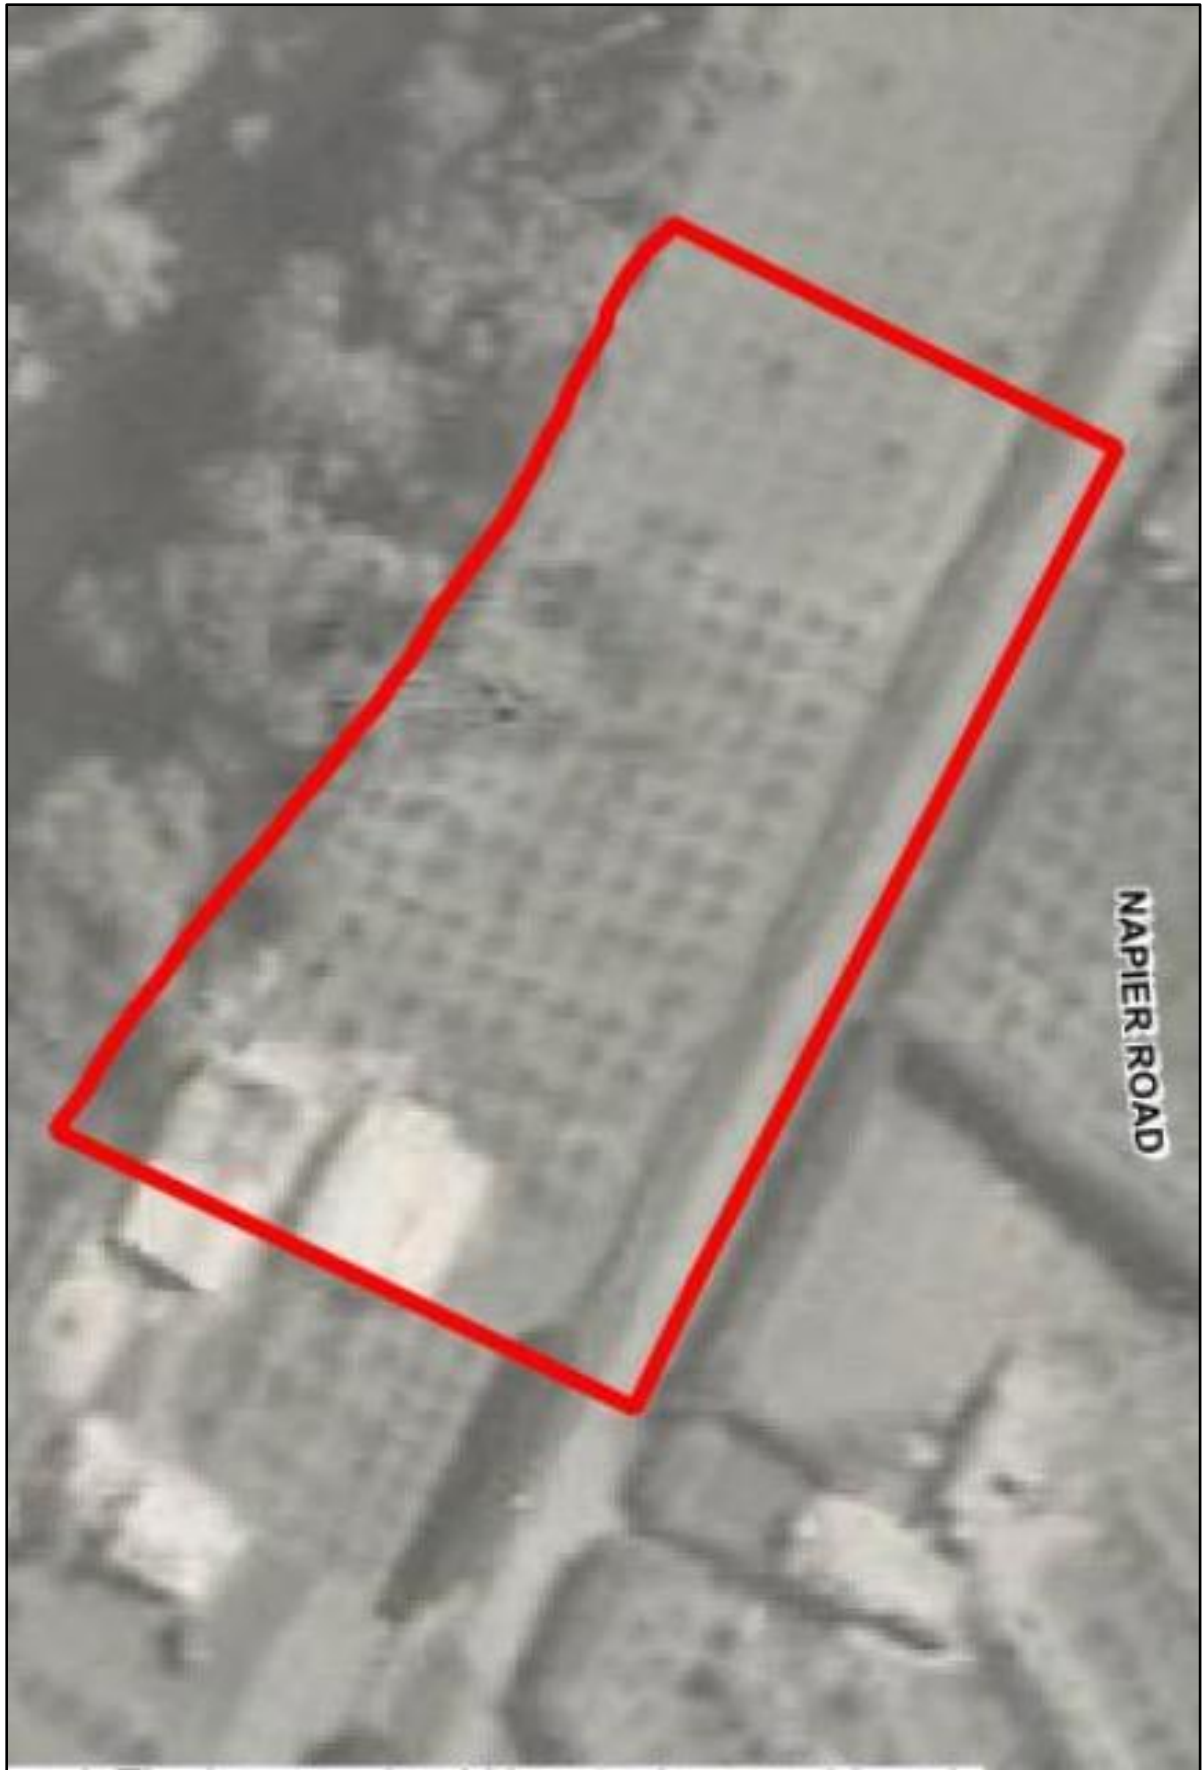
1949-SOURCE, HDC

The earliest historical imagery available is from 1949. Two large buildings are in the south-west corner of the property, and the remainder of the site is planted in orchard. Orchard plants are small in shape and size.

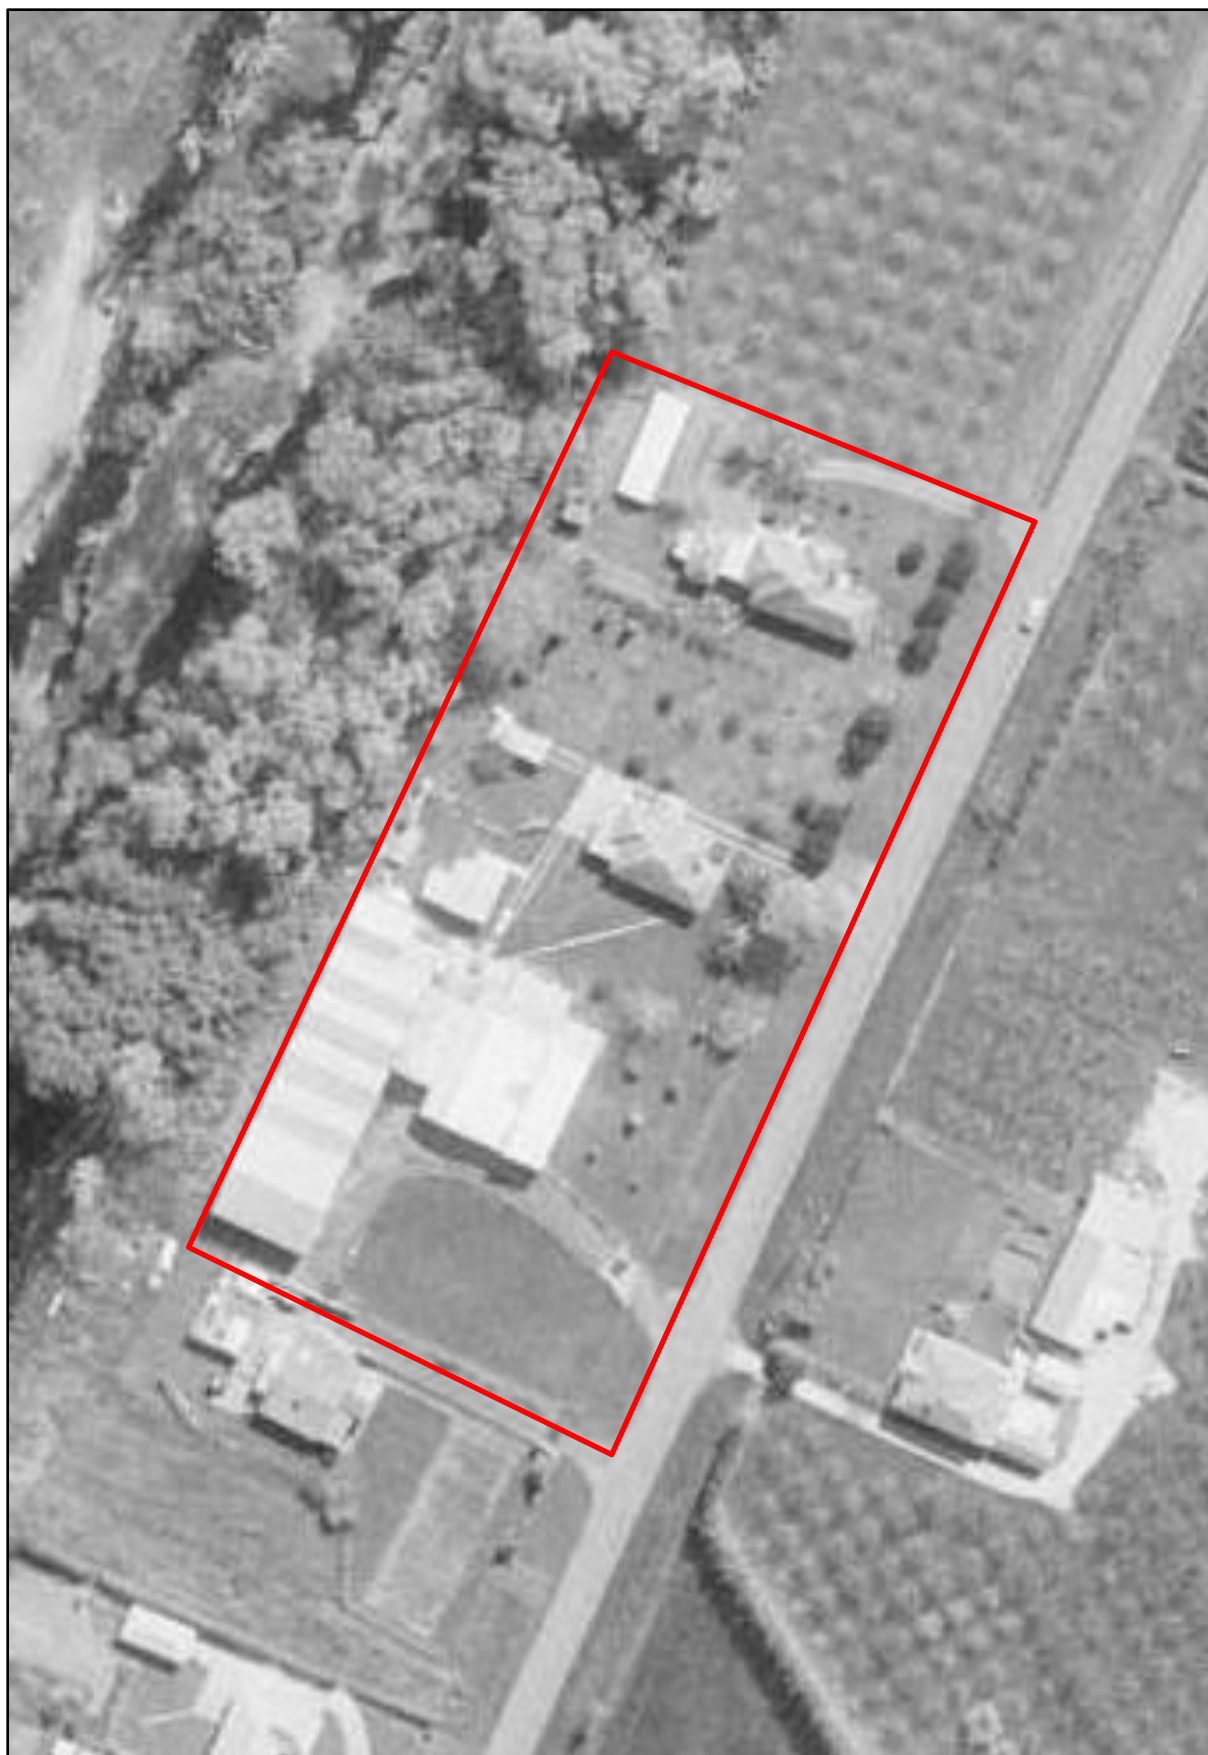
1964- SOURCE, RETROLENS

The next closest available imagery is from 1964 and shows the presence of two large packhouses or cool stores in the south-eastern end of the property, joined by an overhead roof. A driveway extends from the south-eastern corner of the property to these two buildings and suggests an accessway beneath the awning which adjoins the two buildings.

Centrally located within the site is a small shed, a dwelling, and likely a detached garage. The land surrounding this dwelling and garage is grassed with scattered trees. It appears that concrete hardstand is present around the northern side of cool stores.

A second dwelling is present in the north-eastern corner, along with a rectangular shaped object, which is thought to be an implement shed or shopping container.

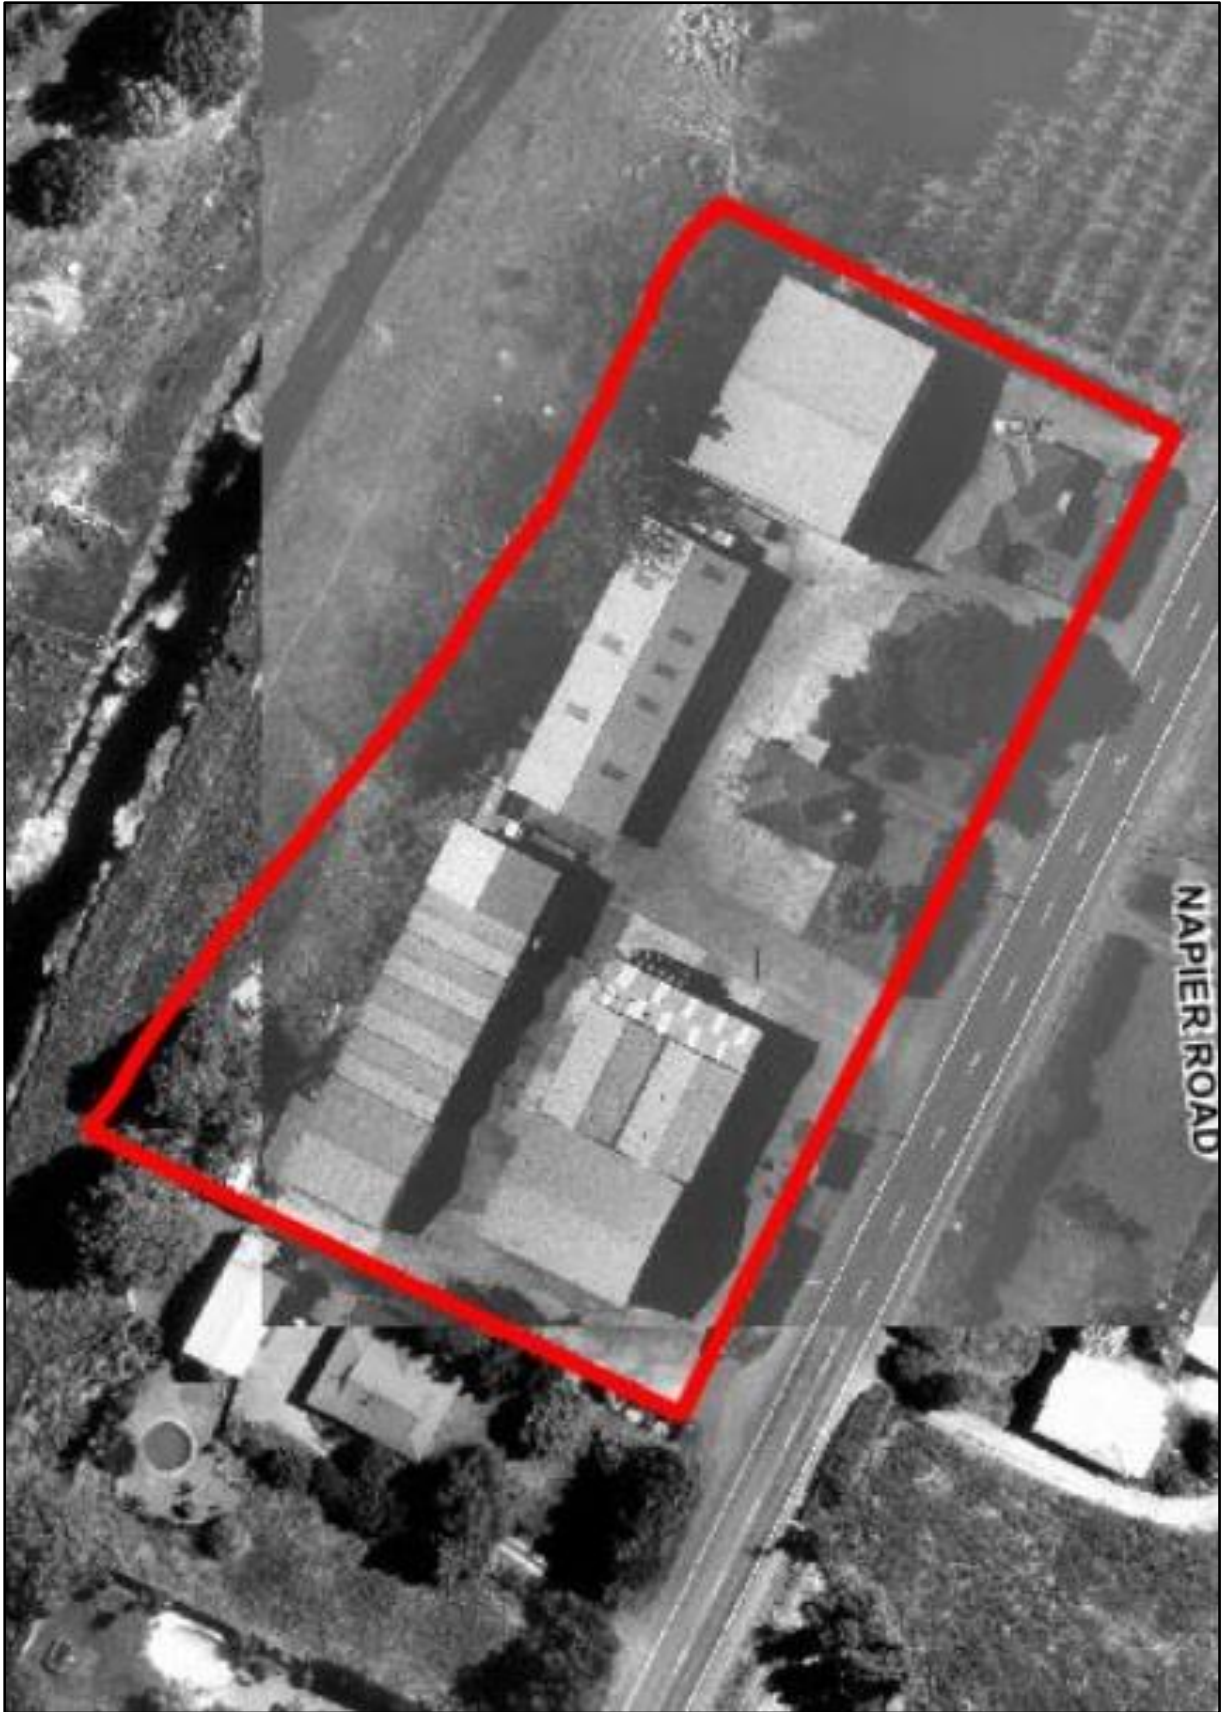
1999- SOURCE, HDC

By 1999, an extension to the cool store in the south-eastern corner is seen, and additional two pack houses are present on the north-west and northern boundary. This agrees with HDC property files for the site.

The dwelling in the north of the site has moved to the north-east boundary, which is likely to have occurred in 1982, as suggested by building consent ABA8913, Application to shift dwelling, 1982. By 1999, the entire site appears covered with concrete hardstand, except for a small, grassed area near the centrally located dwelling.

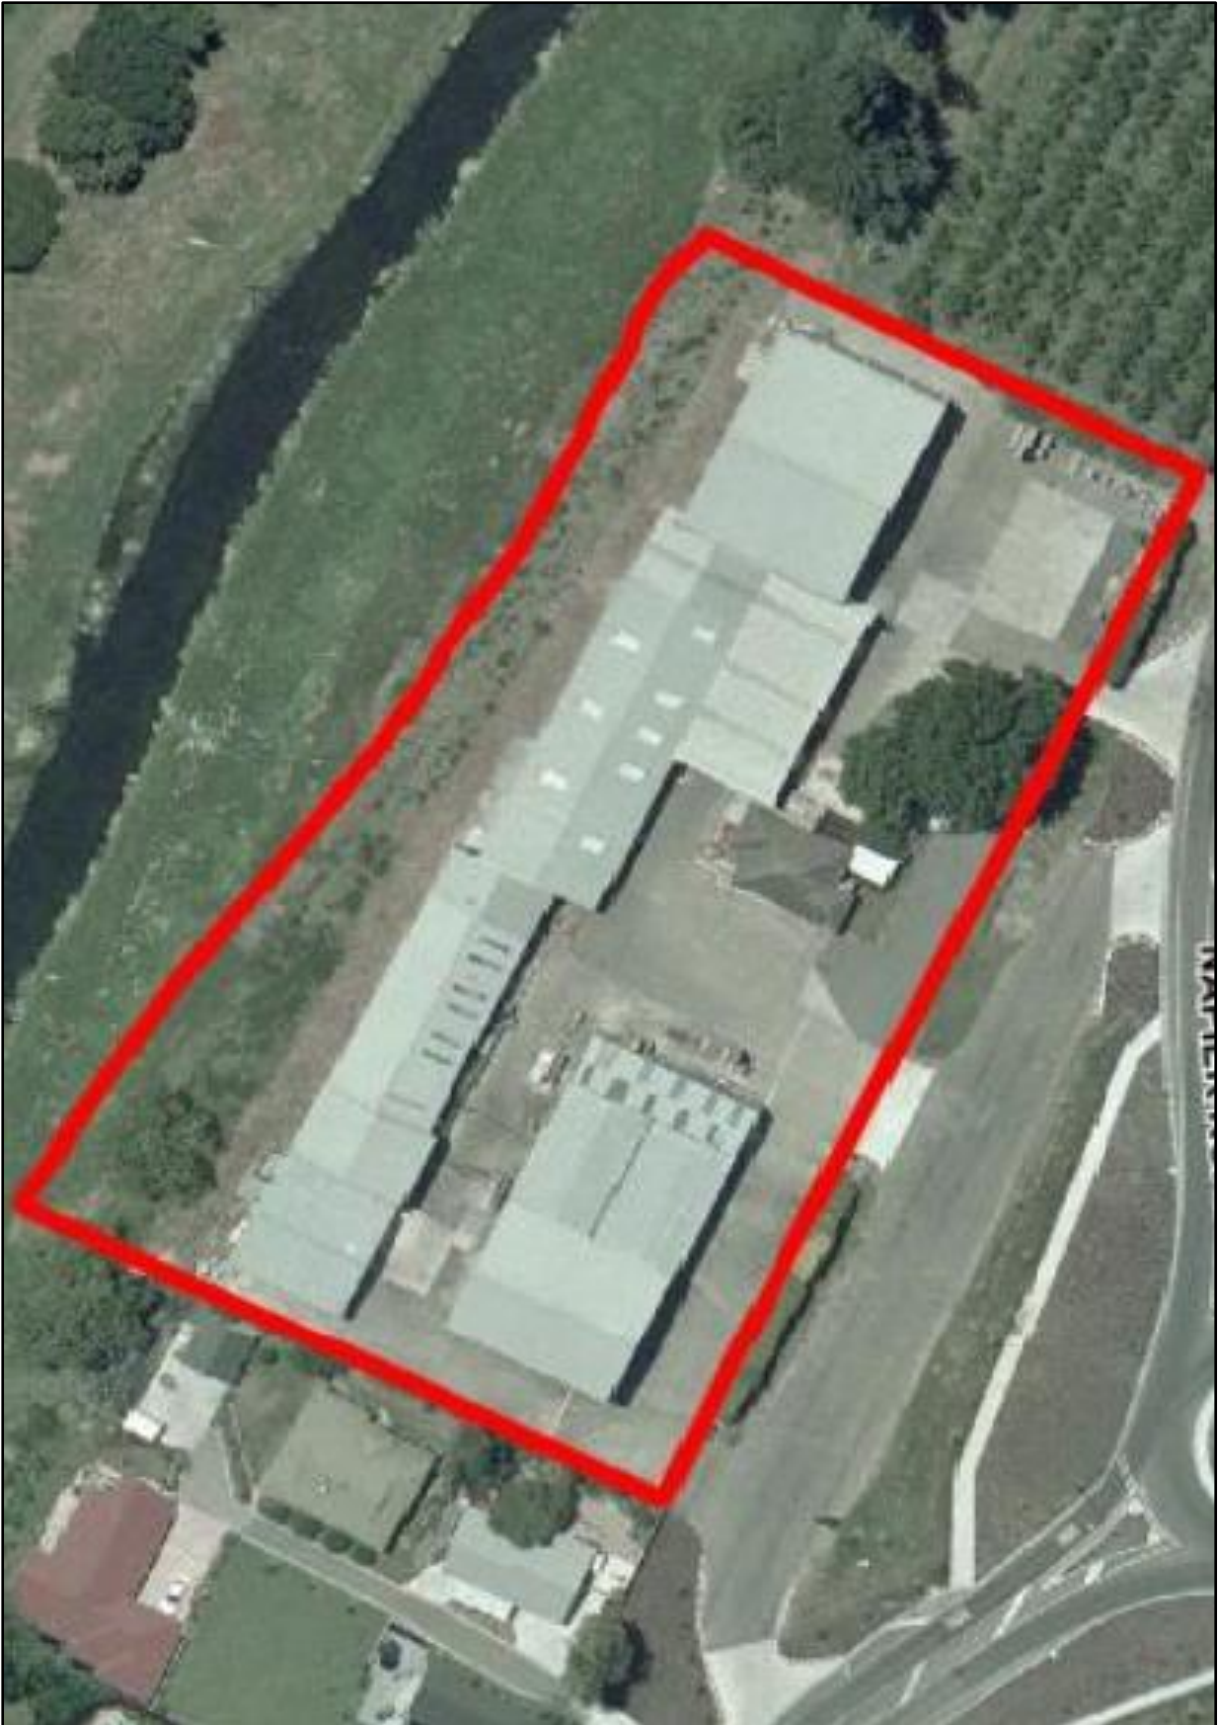
2004- SOURCE, HDC

Imagery from 2004 shows the merging of all buildings on the south-west/ north-western boundary, as they are adjoined with additional building extensions. By this time, the dwelling in the north-east corner has also been removed from the site.

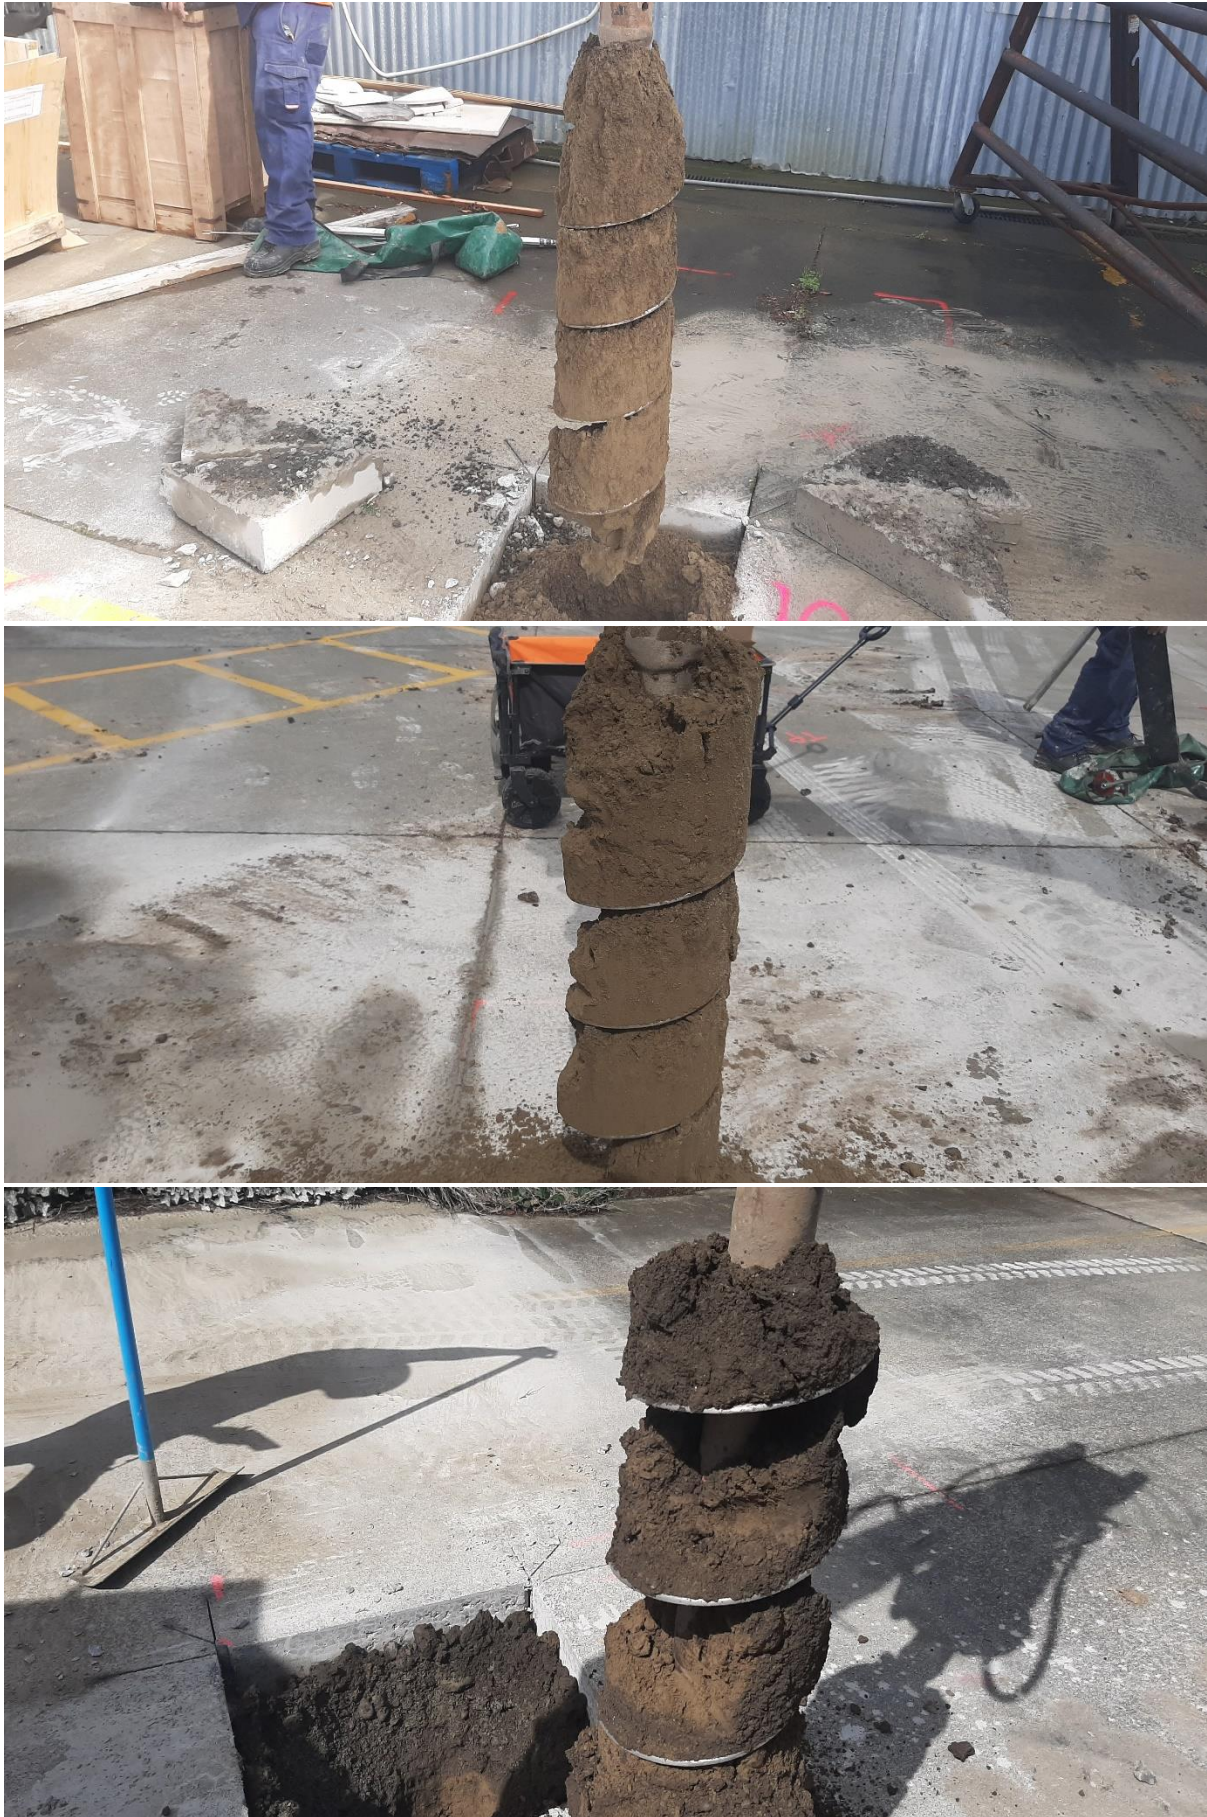
Site soils were observed to be consistent across the site as light brown, fine silty sand to approximately 500-600mm, and light brown sandy silts from 500-600mm to the base of the hole at around 1.0m depth.

Above. Soil cores.
