**REPORT ON:  
GEOTECHNICAL ASSESSMENT**

**PROJECT:  
160 EVENDEN ROAD,  
TWYFORD 4175**

CLIENT: HAMACHEK HOLDING LTD

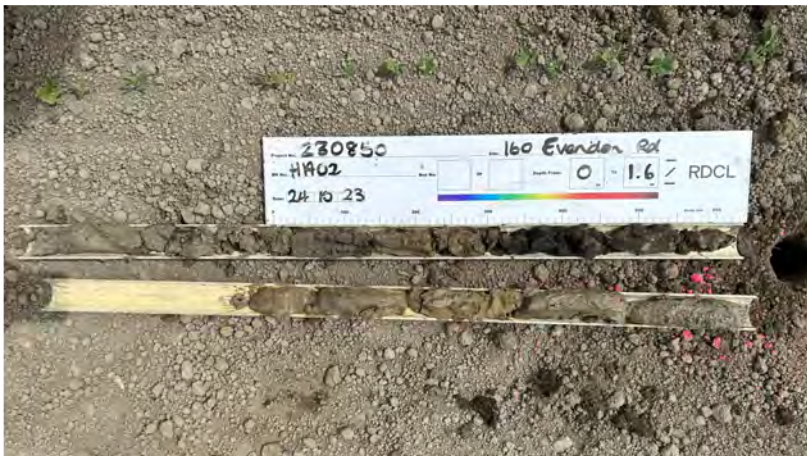
DEPTH (m)	RL (m)	WATER	GRAPHIC LOG	ROCK / SOIL DESCRIPTION	MOISTURE CONDITION	CONSISTENCY / DENSITY	CLASSIFICATION	DCP BLOWS	SAMPLES & TESTS	ADDITIONAL REMARKS
0.0	-0.5		T5 T5 T5	Sandy SILT, with trace rootlets; dark brown. Firm; moist; non-plastic; sand, fine; [TOPSOIL].	M					
0.5	-1.0	▼		Sandy SILT, with minor rootlets and clay; greyish brown with orange mottle. Firm; moist to wet; low plasticity to moderate plasticity; sand, fine.	M to W	FM			FSV: 0.50m 118/47kPa	
1.0	-1.5			0.8m: With minor Pumiceous SAND; sand, fine to coarse; dilatant. 1.0m: Wet.					FSV: 1.20m 145/54kPa	
1.5	-2.0			SAND; blue with orange and grey mottle. Medium dense; wet; sand, fine to coarse, quick.	W	MD				
2.0	-2.5			EOH: 1.60m Termination: Sample Washout - No Sample Recovery						
2.5	-3.0									
3.0	-3.5									
3.5	-4.0									
4.0	-4.5									
4.5	-4.5

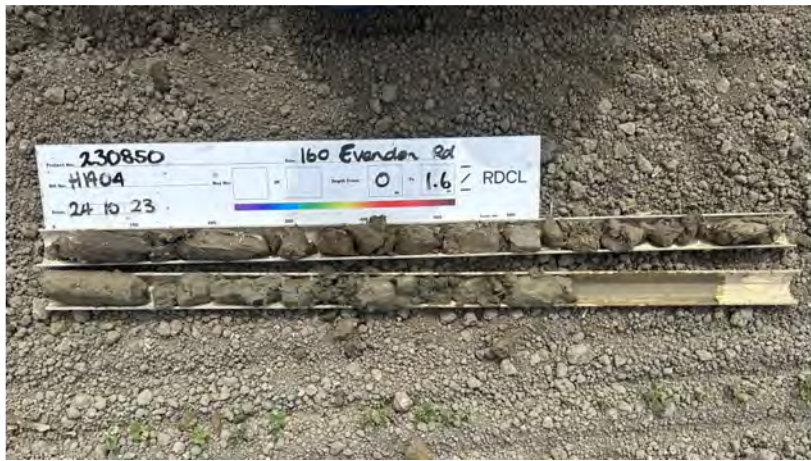
DEPTH (m)	RL (m)	WATER	GRAPHIC LOG	ROCK / SOIL DESCRIPTION	MOISTURE CONDITION	CONSISTENCY / DENSITY	CLASSIFICATION	DCP BLOWS	SAMPLES & TESTS	ADDITIONAL REMARKS
0.0	-0.5		T5	Sandy SILT, with trace rootlets; dark brown. Firm; moist; non-plastic; sand, fine; [TOPSOIL].						
0.5	-1.0			Sandy SILT, with minor clay; greyish brown with orange mottle. Firm; moist; low plasticity; sand, fine to medium.	M	FM			<ul style="list-style-type: none"> <li>FSV: 0.30m 168/50kPa</li> <li>FSV: 0.90m 135/47kPa</li> <li>FSV: 1.10m 185/74kPa</li> </ul>	
1.5	-1.5			SAND, with minor silt; greyish blue with orange and blue mottle. Medium dense; moist to wet; sand, fine to coarse, quick.	M to W	MD				
2.0	-2.0			1.5m: Wet. EOH: 1.60m Termination: Sample Washout - No Sample Recovery						
2.5	-2.5									
3.0	-3.0									
3.5	-3.5									
4.0	-4.0									
4.5	-4.5

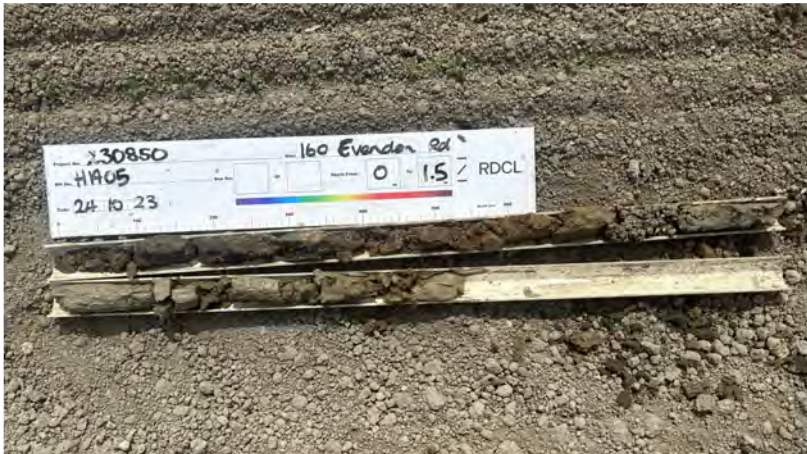
DEPTH (m)	RL (m)	WATER	GRAPHIC LOG	ROCK / SOIL DESCRIPTION	MOISTURE CONDITION	CONSISTENCY / DENSITY	CLASSIFICATION	DCP BLOWS	SAMPLES & TESTS	ADDITIONAL REMARKS
0.0	-0.5		T5 T3 T1	Sandy SILT, with trace rootlets; dark brown. Firm; moist; non-plastic; sand, fine; [TOPSOIL].						
0.5	-1.0			Sandy SILT, with some clay, with minor rootlets; light brown with orange and grey mottle. Firm; moist; low plasticity to moderate plasticity; sand, fine.	M	FM			FSV: 0.30m 135/34kPa	
1.0	-1.5			0.8m - 0.9m: With some Pumiceous SAND.						
1.5	-2.0			SAND, with minor silt; greyish brown with orange and bluish mottle. Medium dense to dense; wet; sand, fine to coarse, quick.	W	MD to D				
2.0	-2.5			EOH: 1.50m Termination: Sample Washout - No Sample Recovery

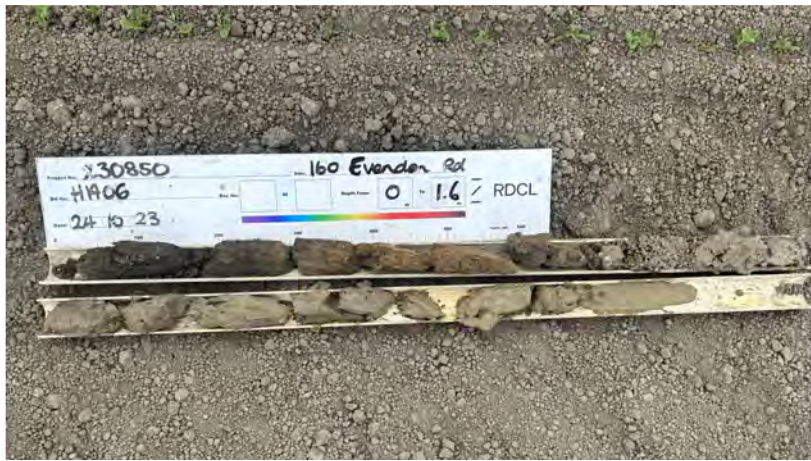
DEPTH (m)	RL (m)	WATER	GRAPHIC LOG	ROCK / SOIL DESCRIPTION	MOISTURE CONDITION	CONSISTENCY / DENSITY	CLASSIFICATION	DCP BLOWS	SAMPLES & TESTS	ADDITIONAL REMARKS
0.0	-0.5		TS TS TS	Sandy SILT, with trace rootlets; dark brown. Firm; moist; non-plastic; sand, fine; [TOPSOIL].						
0.5	-1.0			Sandy SILT, with minor rootlets and clay; greyish brown with orange and grey mottle. Firm; moist; low plasticity to moderate plasticity; sand, fine to medium.	M	FM			FSV: 0.60m 168/64kPa	
1.0	-1.5	▼		0.8m - 0.9m: With some Pumiceous SAND; sand, coarse. 1.0m: Wet.						
1.5	-2.0			SAND, with minor silt; greyish brown with orange and grey mottle. Medium dense; moist to wet; sand, fine to coarse, quick.	M to W	MD				
2.0	-2.5			EOH: 1.60m Termination: Sample Washout - No Sample Recovery						
2.5	-3.0									
3.0	-3.5									
3.5	-4.0									
4.0	-4.5

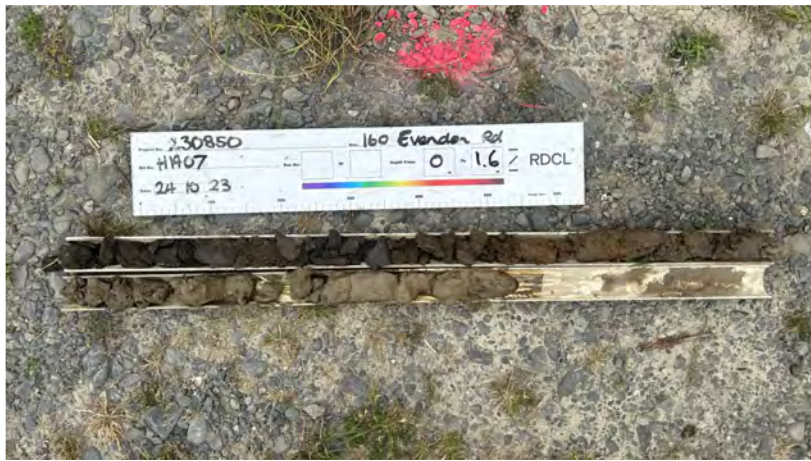
Sandy SILT, with trace rootlets; dark brown with some orange and black mottle. Firm; moist; non-plastic; sand, fine; [TOPSOIL].	M	FM			FSV: 0.60m 118/50kPa		
1.0	-1.0			Sandy SILT, with trace wood fragments; light brown with orange, white and black mottle. Firm; moist; non-plastic; sand, fine to medium.						FSV: 1.10m 124/47kPa	
1.5	-1.5			Silty SAND; greyish brown with some white and orange mottle. Medium dense; moist; sand, fine to medium, quick.					MD		
2.0	-2.0			EOH: 1.60m Termination: Sample Washout - No Sample Recovery

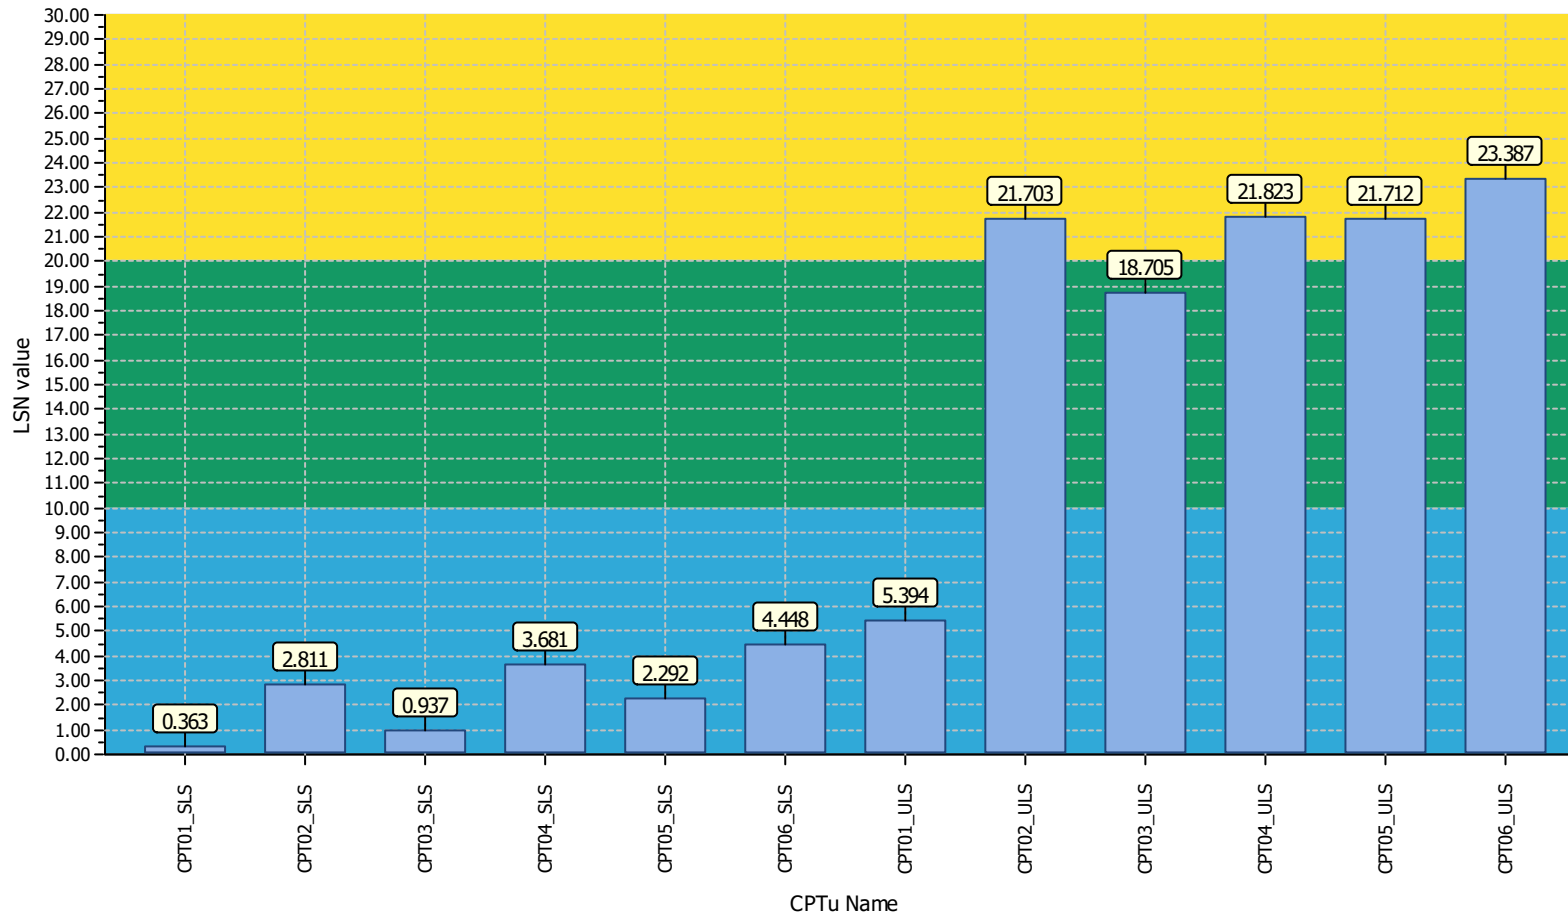
### Overall Liquefaction Severity Number report

- Severe damage
- Major expression of liquefaction
- Moderate to severe exp. of liquefaction
- Moderate expression of liquefaction
- Minor expression of liquefaction
- Little to no expression of liquefaction
